## Encircle Sample Report

Water

159 North Lake Drive, Waterloo, Ontario

## Claim Summary

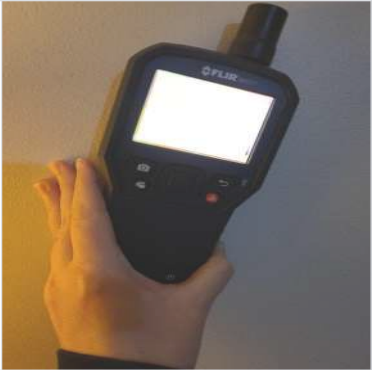
Point 1: Moisture Point 1

1: Drywall

#	Time	Meter	Moisture Content	Surface Temperature	Notes & Photos
1	Nov 2, 3:41 PM	Flir 100%	100%

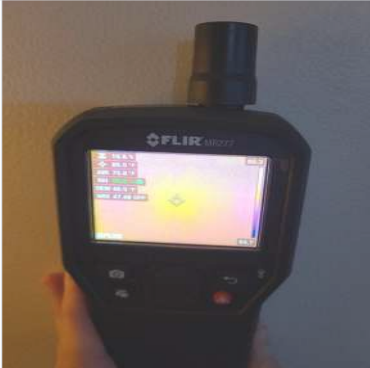
Point 2: Moisture Point 2

#	Time	Meter	Moisture Content	Surface Temperature	Notes & Photos
3	Nov 4, 4:52 PM	Flir 100%	6.1%

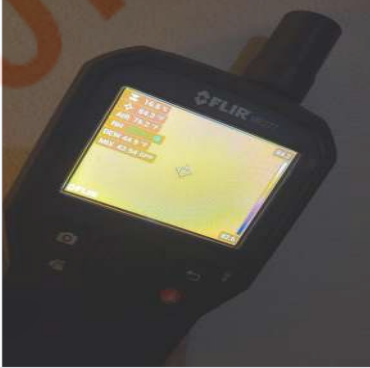
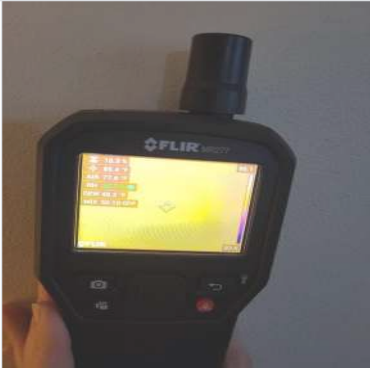
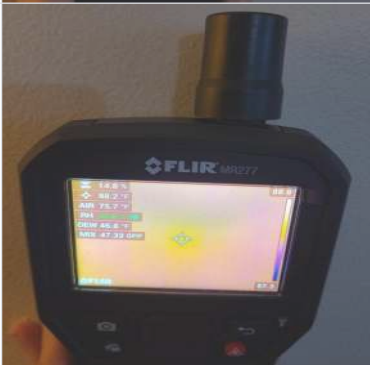
Point 3: Moisture Point 3

#	Time	Meter	Moisture Content	Surface Temperature	Notes & Photos
1	Nov 2, 3:42 PM	Flir 100%	100%

2	Nov 3, 3:38 PM	Flir 100%	51%

3	Nov 4, 4:51 PM	Flir 100%	6.4%

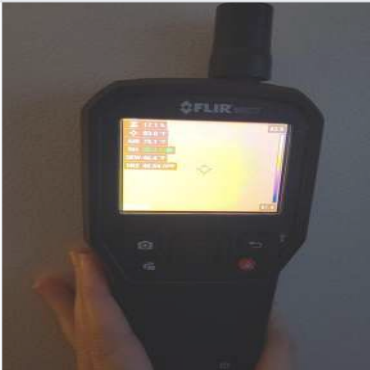
Point 2: Moisture Point 2

#	Time	Meter	Moisture Content	Surface Temperature	Notes & Photos
1	Nov 2, 3:46 PM	Flir 100%	100%		
2	Nov 3, 3:36 PM	Flir 100%	52%

#	Time	Meter	Moisture Content	Surface Temperature	Notes & Photos
3	Nov 4, 4:49 PM	Flir 100%	6.2%
