Example Aerial Inspection Surveys and Reports

Activity: Aerial Inspection of Flare Stack and Tip

SURVEY EXCERPT 1: JUNE 30, 2016

SURVEY EXCERPT 2: OCTOBER 18, 2012

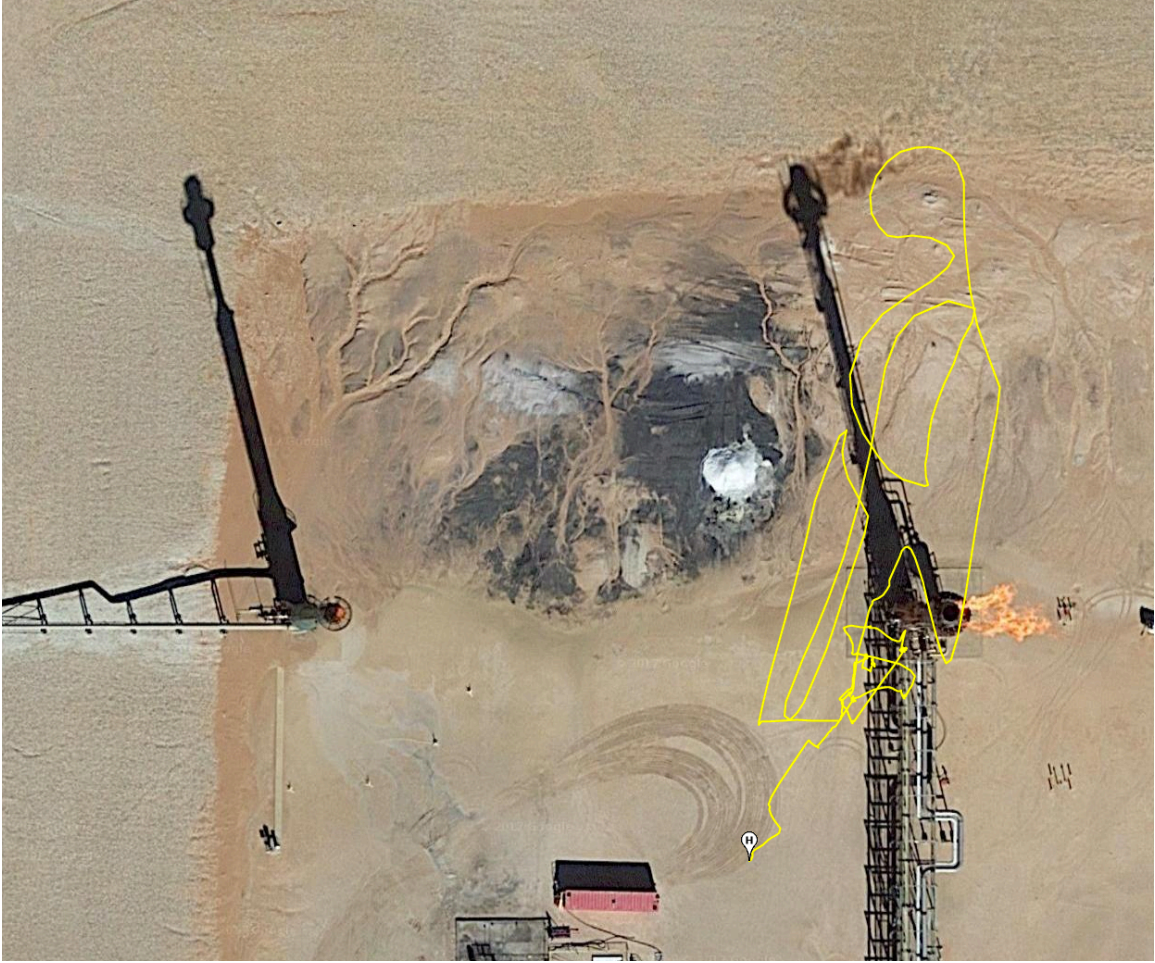
1. Existing Flare Tip Design
 - a. Cause of Smoking
 - i. The smoking observed by [REDACTED] at turndown rates is the result of internal burning. Internal burning is detected in the drone inspection video looking down into the flare tips vanes and further confirmed by the smoke emitted from the flare tip vanes, rather than the end of the flame itself. This smoking is not due to insufficient of assist air from the fan.
 - ii. Smoking resultant from insufficient assist air would be emitted from a visible flame and would initiate from the end of the flame.

- iii. The existing flare tip design promotes internal burning during most average wind events. During the inspection [REDACTED] attended, any wind over 10-12 MPH caused the combustion to stabilize inside the flare tip and emit smoke from the downwind flare tip vanes. The long vanes of the existing flare tip promote a chimney effect to be established during low flow conditions. [REDACTED] air-assisted flare tips utilize short vanes that allow the wind to dominate at turndown cases to push the flame out of the tip. [REDACTED] design does not promote the formation of a draft to feed internal combustion.
