Texas Landmark Church Roof Replacement

Chamberlin Roofing & Waterproofing re-roofed St. Andrew's Episcopal Church in Fort Worth, Texas, to remedy water intrusion and hail damage.

Sealant Performance and Compatibility: The Great Disconnect

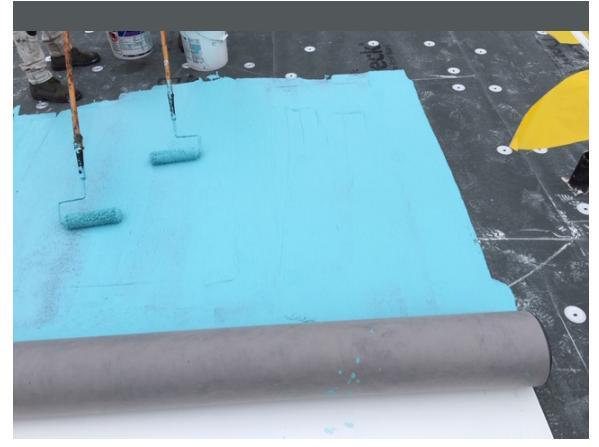
Chamberlin installed a 60-mil fleeceback TPO membrane with a water-based adhesive.

To begin, the existing modified bitumen roofing system was removed. Then two layers of 2.6inch Polyiso insulation was installed, followed by a one-half inch cover board. Finally, a 60-mil fleeceback TPO membrane was adhered to the substrate. Copper flashing pieces were fabricated by Chamberlin sheet metal experts and installed with fasteners. The asphalt-stained slate roofing was removed and re-installed. Where the six-layer felt system underneath the slate roofing was damaged in some areas, Chamberlin installed an Ice and Water Shield vapor barrier providing moisture protection for the plywood decking underneath to help mitigate water infiltration into the building.

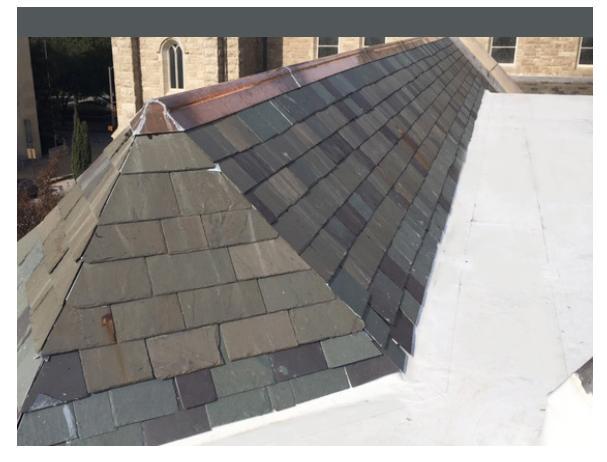
The top two rows of asphalt-stained slate roofing on the roof peaks were removed and new shingles were installed.

On the roof peaks, the original slate shingles were installed with an asphalt underlayment. A combination of the weight of the slate and high Texas temperatures over the years had caused the asphalt underlayment to melt. This liquid seeped out of the top of the peak where the slate meets the copper ridge and dripped down onto the top two rows of shingles. The original slate roofing was custom made, and Chamberlin was challenged with finding the manufacturer. Research uncovered a company overseas from whom the slate could be purchased, factoring a delivery time of three to four weeks into the schedule as it would be shipped by boat.

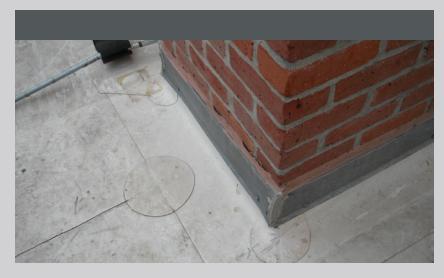
Adhesion sealant failure adjacent to brick.

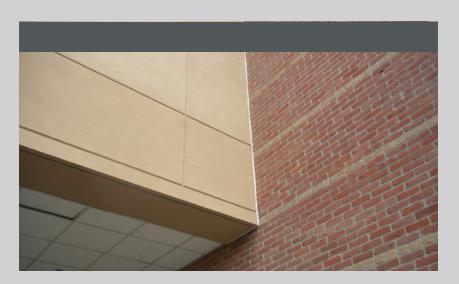
EIFS sealant joints should be applied to the base coat.

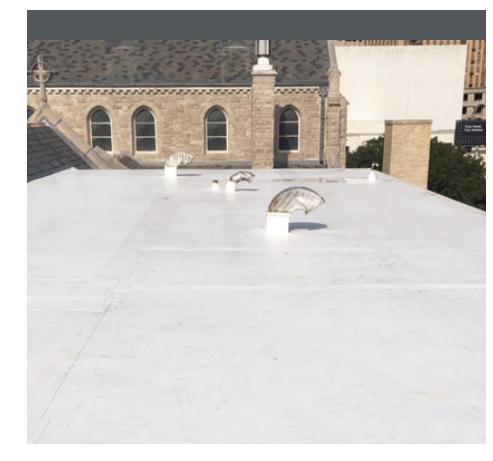
Completed TPO roofing system installed on St. Andrew's Episcopal church.

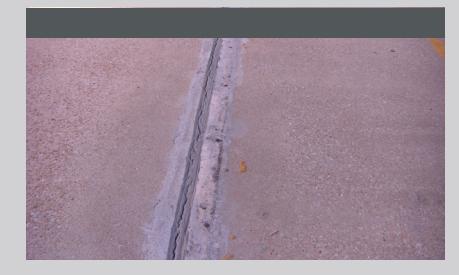
Urethane sealant failure resulting from application during cold weather.

Under direct UV exposure, heat oxidation can cause deterioration of urethane sealants in less than three years. The reported satisfactory performance of exposed urethane sealants is in the range of five to eight years. Few if any Owners or Property Managers budget for and implement replacing failed joint sealants every three to eight years. The great disconnect is the short-term mindset of creating building envelope barrier systems and sealing exposed exterior joint openings with urethane sealants versus long-term performance expectations and project needs.

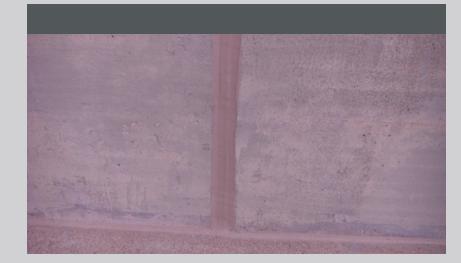
Sealant joint materials at intersections should be compatible.

Sealant compatibility with air barriers, moisture-resistive barriers and selfadhered modified bitumen wraps and flashings is most important to longterm adhesion. Adequate adhesion can only be obtained with sealant, building wrap and flashing compatibility. Sealant selection needs to be driven by the recommendation of the substrate component manufacturer.

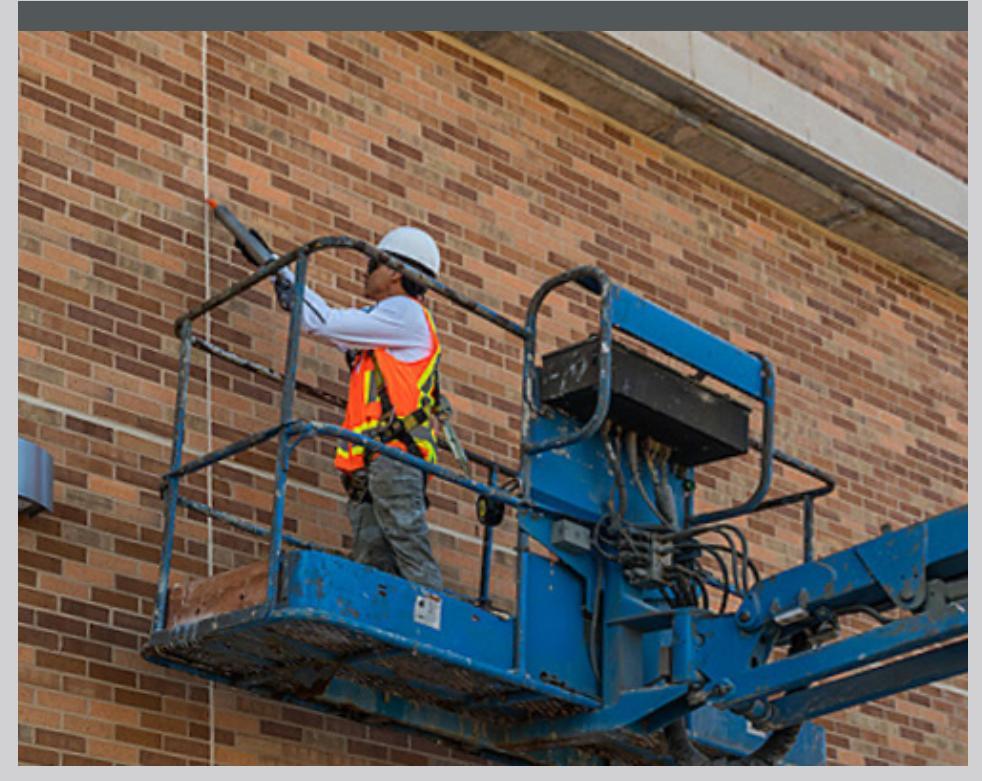
Installing silicone sealant on brick facade.
