CHAMBERLIN

Waterproofing Details Can Make All The Difference

INTEGRIS Baptist Medical Center in Oklahoma City, Oklahoma

SPRING 2016

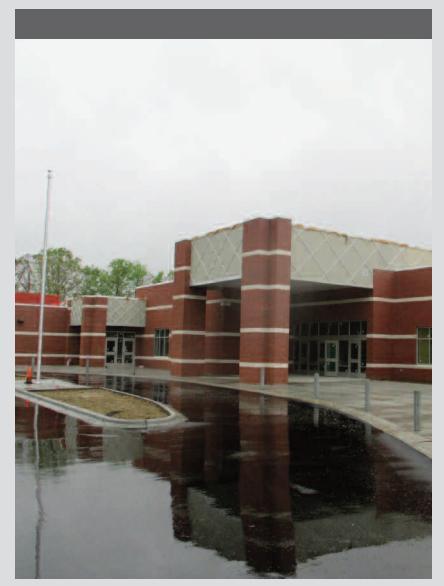
Charlotte-Mecklenburg Schools incorporated air barrier testing for all new buildings, major renovations and additions.

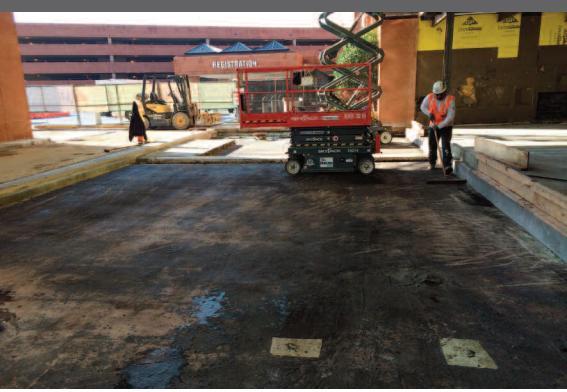
Chamberlin removed the old waterproofing at the hospital entrance to prepare for the new system.

To begin, the failing waterproofing system was removed. After the concrete was demolished, the Chamberlin crew got to work removing the old waterproofing with scrapers and grinders. The desired effect of this removal process was a rough substrate to which the new waterproofing system could easily adhere. Next, Flintco installed new curbs and mortar

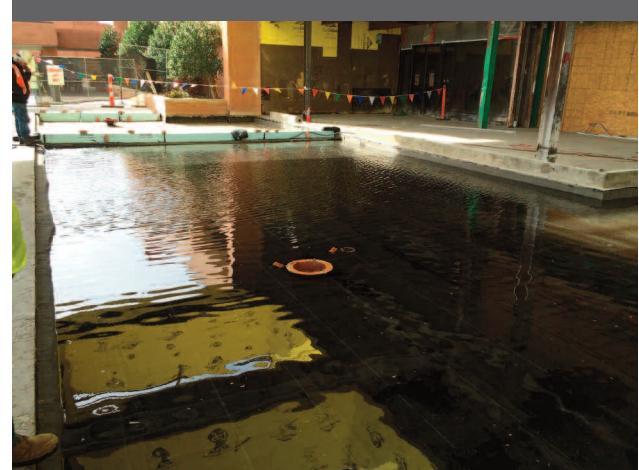
A water test was performed to check for leaks.

Once the entire waterproofing system was installed, Chamberlin performed a water test. The waterproofed area was filled with water. The amount of water was measured when it was filled and then again 24 hours later. If any water was lost, it could indicate a leak in the system. However, the system proved watertight, so Chamberlin proceeded with installing the cap sheet and drainage mat. To complete the process, the insulation was installed and the top level of concrete was poured.

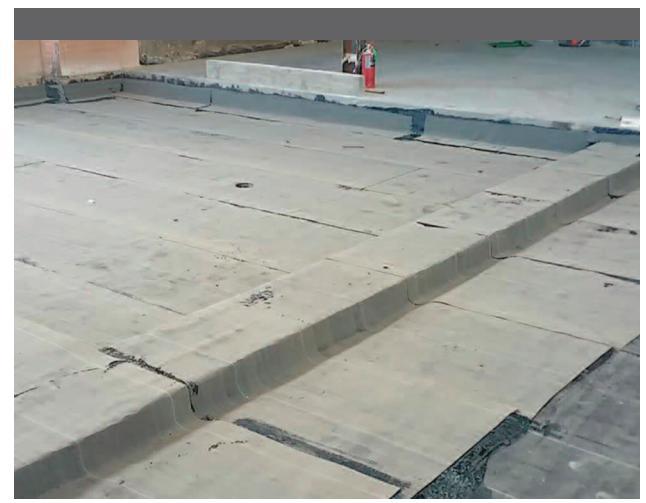
The completed hot fluid-applied waterproofing system before concrete is poured.

Chamberlin crew members diligently applied the first layer of waterproofing. Then a mesh reinforcing fabric was installed to give rigidity to the waterproofing system. Next, a second layer of hot fluid-applied waterproofing was installed. Chamberlin and the waterproofing material manufacturer conducted millage testing throughout the project for quality control.

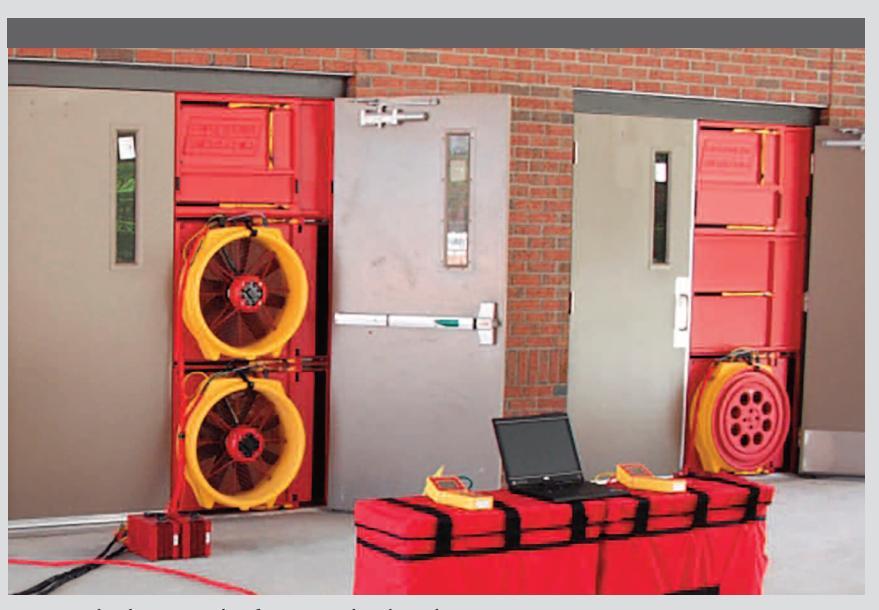
Fans were placed in exterior door frames to conduct the air barrier test.

set in a plastic frame which was placed in an exterior door frame. The three fans were connected to controllers which adjust the fan speed based on the pressure in the building. A computer records the flow through the fans and dictates to the controllers what the required pressures shall be throughout the test.

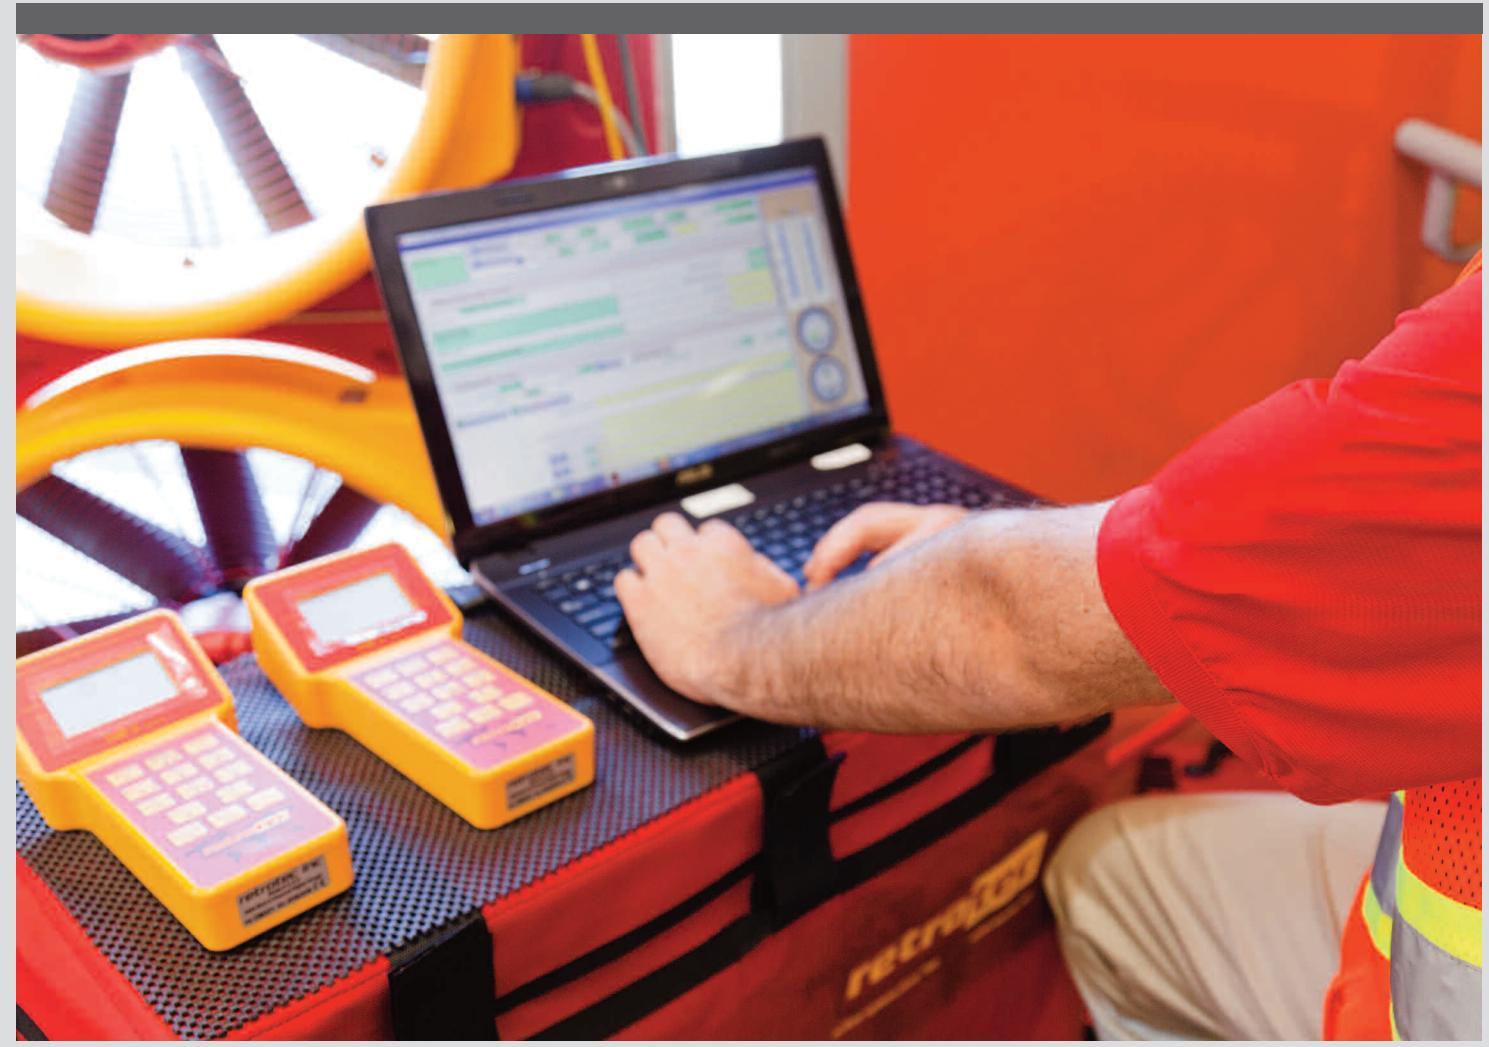
A computer records the flow through the fans and dictates to the controllers what the required pressures shall be throughout the test.

The flow through the building enclosure was recorded at 10 different pressure points. These points were placed on a graph which created a straight line that was then used to calculate the flow through the building enclosure at 75 Pascals, a unit of pressure in metric units.
