CHAMBERLIN

NEWSLETTER

Chamberlin Revitalizes San Antonio High-Rise

SPRING 2018

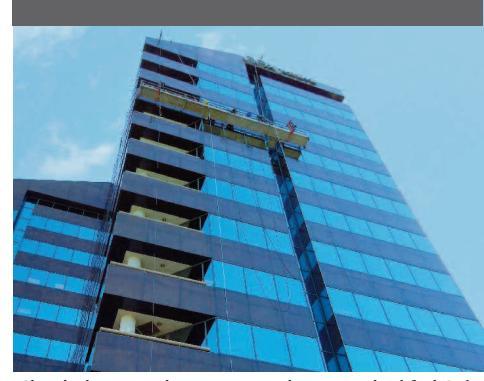
Chamberlin executed 20 swing stage drops around Ashford Oaks to perform the complete replacement of all sealants on the building envelope.

Chamberlin completed 20 drops around the building during their scope. Attention to detail was crucial for safely rigging the swing stage each time. The crew would lower the stage to the ground and then start the process of moving the swing stage, outriggers and weights to the new drop location. There, the swing stage was reconstructed and secured to tieback anchor points. Chamberlin's crew members were tied off with separate lifelines and anchor points.

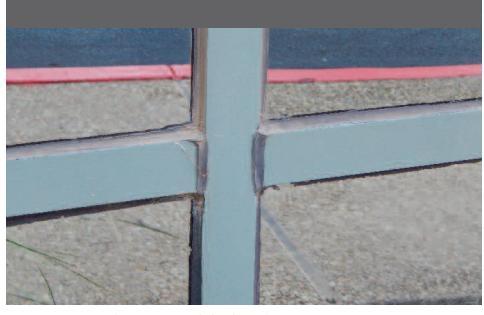
Existing wet glazing at Ashford Oaks.

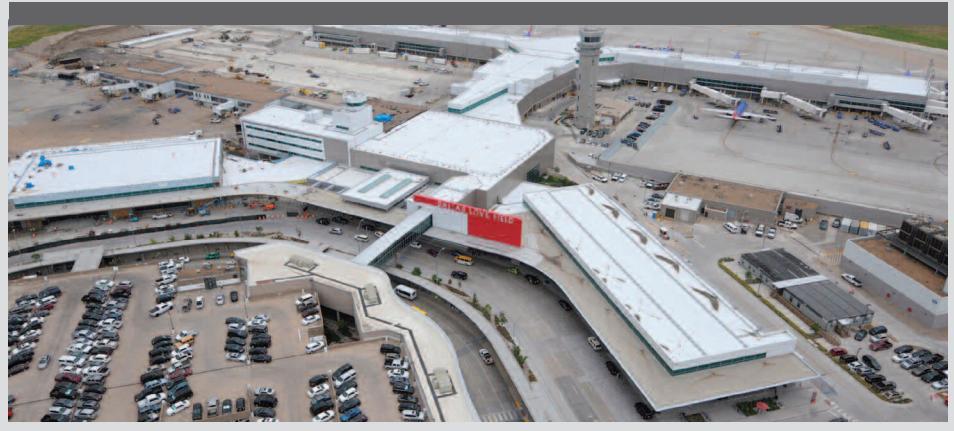
Soprema two-ply modified bitumen roofing system, GAF PVC roofing system and Firestone TPO roofing systems installed at Dallas Love Field airport. Photo courtesy of Chamberlin Roofing & Waterproofing.

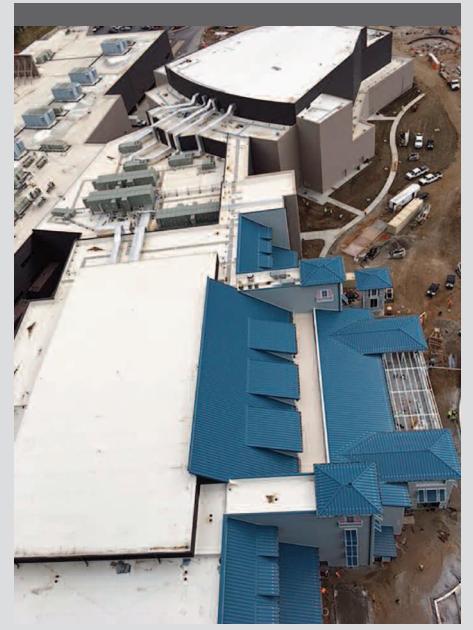
Carlisle PVC roofing system installed on River Spirit Casino and Margaritaville Resort. Photo courtesy of Chamberlin Roofing & Waterproofing.

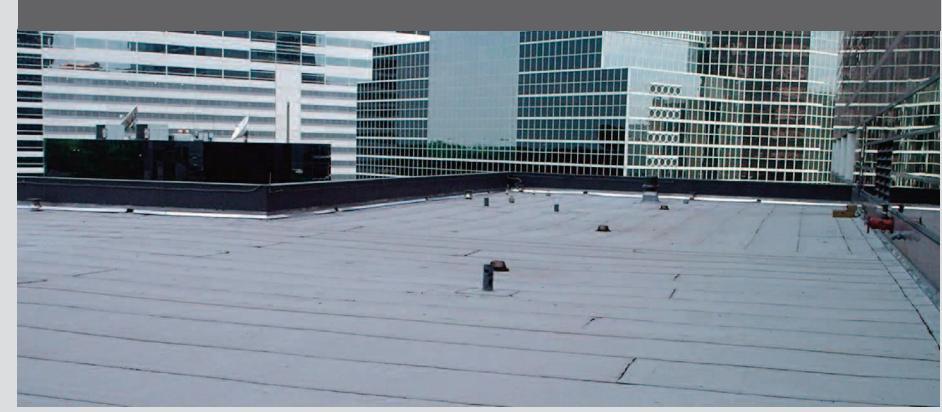
Completed modified bitumen roofing system on Texas Children's Hospital. Photo courtesy of Chamberlin Roofing & Waterproofing.
