Specialty Industrial Corrosion Products Demand ChemLine[®] Protective Coating System

City of Margate, Florida Relies on ChemLine® to Protect Wastewater Structures

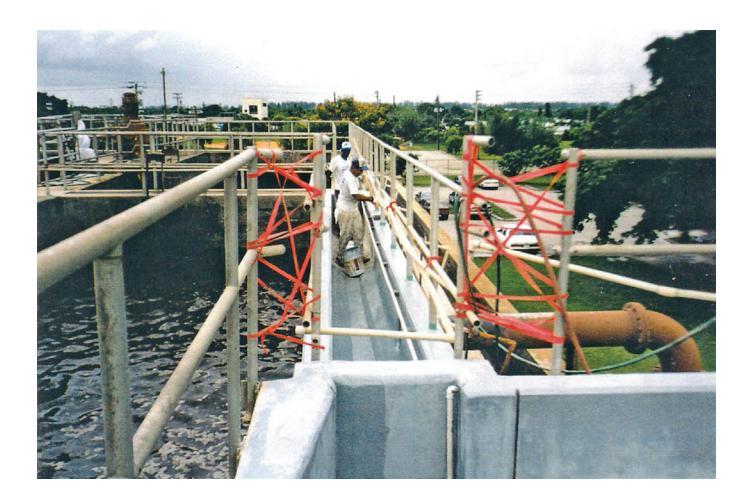
Inspecting the ChemLine[®] coating system on the aeration structure.

As a result, the structures were rebuilt with a special mortar and then recoated 24 hours later with ChemLine®.

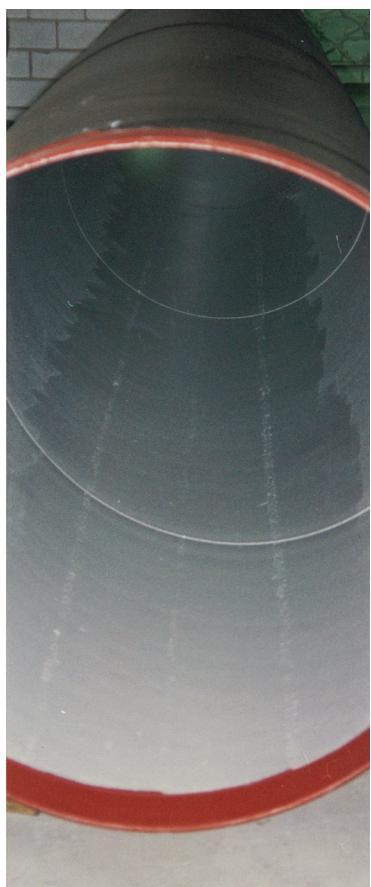
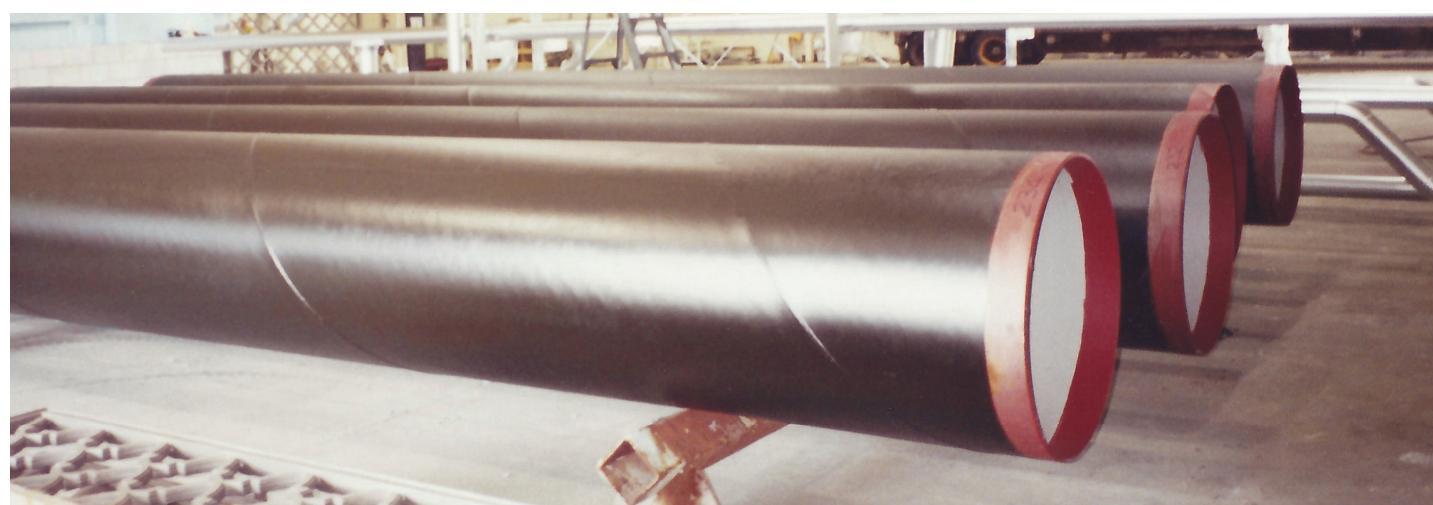
ChemLine[®] coatings are used to handle the tough conditions of oil well piping for the crude oil industry.

Other key benefits of the ChemLine[®] coating for this application included its ambient cured formulation and its ease of application. Pipes in 40foot lengths were lined using automatic spray equipment. Two coats of ChemLine[®] were applied to a thickness of 20-22 mills.

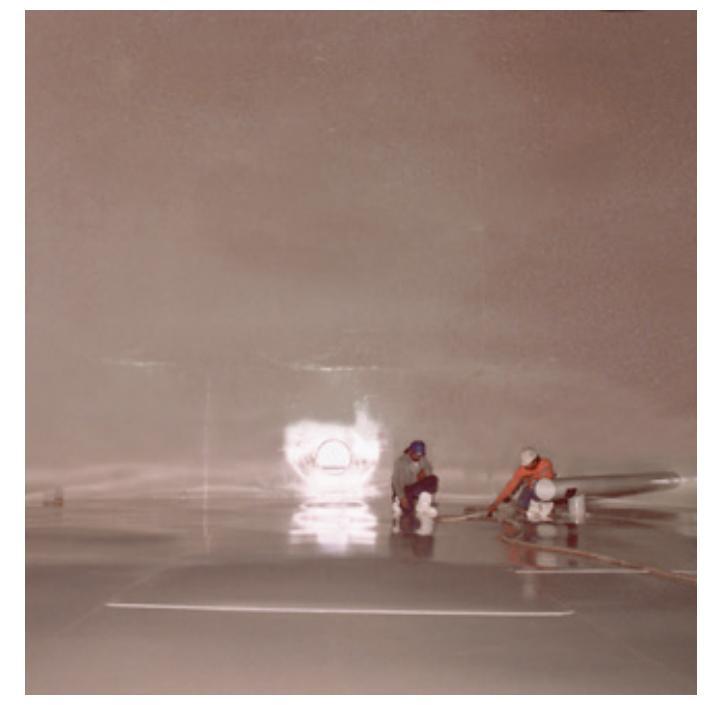
The loss was caused by the outside air entering the tank and lowering the Sulfuric Acid concentration in the upper portion of the tank.

Inspecting tank bottom after the APC ChemLine[®] tank coating application.

BP replaced the corroded steel plates and coated the complete tank with APC's ChemLine[®] coating system. A ChemLine[®]-composite dip tube was installed to handle loading and uploading.

After five years of continuous service, the ChemLine $^{\otimes}$ coating and composite pipe have performed well, only having lost their gloss.

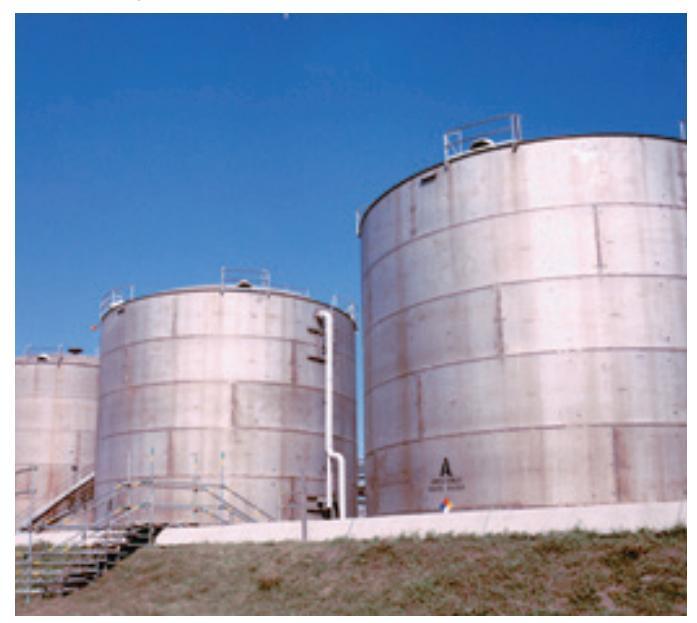
BP's stainless steel tanks at the Port Lavaca, Texas facility were being eaten away by a bacteria known as MIC. The micro-organism is introduced to the acrylonitrile tanks through the tanks' waste water system. The bacteria creates small cracks in the tanks' stainless steel walls that are then attacked by other chemicals (Acrylonitrile, Hydrogen Cyanide, Acetonitrile, and Benzene) in the unfiltered waste water which is at a 160°F temperature.

Stainless steel tanks lined with ChemLine[®] coating prevent corrosion.

These tanks were lined with APC's $\mbox{ChemLine}^{\circledast}$ system and have now solved this corrosion problem.
