New solution to a perplexing problem ... or should I say pileated problem?

BY RICHARD HEVERLEY

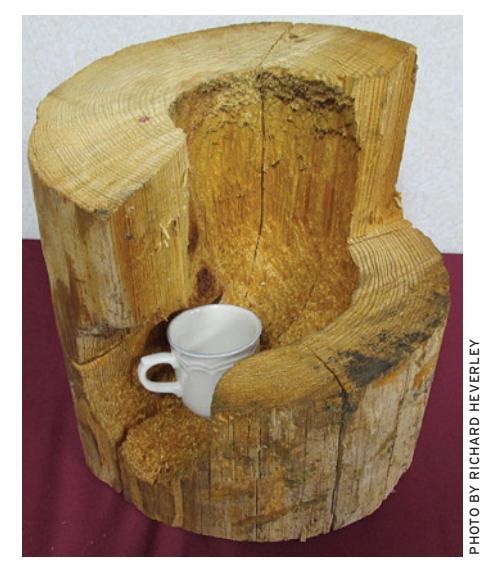
PERSISTENT WOODPECKERS: This is the top section of one of the poles, which is almost 14 inches in diameter. The cavity the woodpecker made in the pole's center is about 7 inches in diameter and 14 inches long. I could have easily put a half-gallon milk jug inside it to give you perspective, instead of the coffee cup, but you get the point – these holes are big. This is just one of over a dozen woodpecker holes in this pole alone.

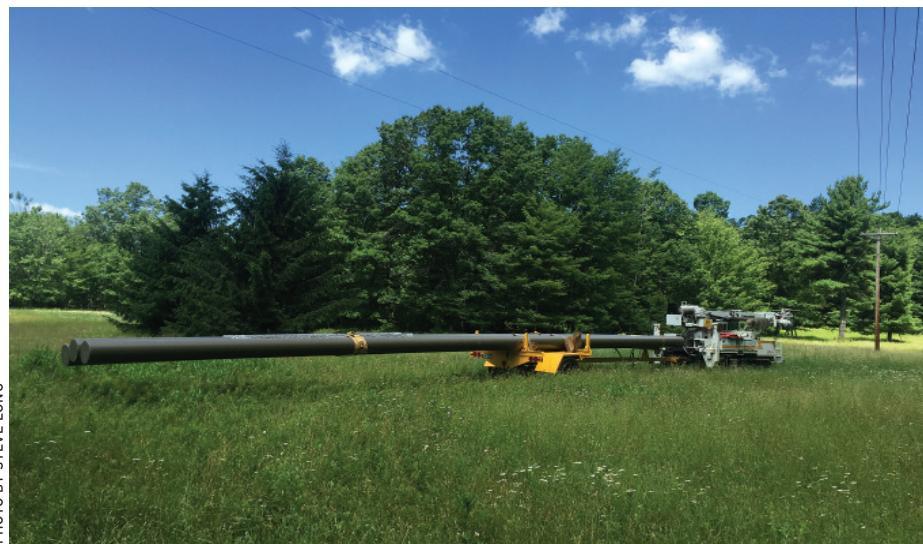
POLES TO THE JOB SITE: BNF Line Construction (the contractor we used to complete this project) hauls three of the poles up the right-of-way to the job site. Each side of the crossings at Moravian Run required three of these 60-foot-long, 1,394-pound fiberglass poles.

The company selected to provide the fiberglass poles was Creative Pultrusions Inc. (CPI), located in Alum Bank, Pa. United Electric's engineering department began working with the engineers at CPI designing the custom poles that would meet the needs of this particular project. Due to the specialized nature of working with fiberglass poles, all of the needed hardware and cross beams were designed and provided by CPI to ensure the job would be completed with no damage or undue stress points on the poles.

It took about three months for Steve and his staff to be sure all of our concerns were addressed prior to ordering the material needed to complete the job. The poles would be 16 inches in diameter from the top cap to the bottom plug, with 1/2-inch fiberglass and vinyl resin walls, and weigh 1,394 pounds. After allowing another month for the actual production of the poles and crossbeams, the material was finally ready and the pole replacement project could begin.

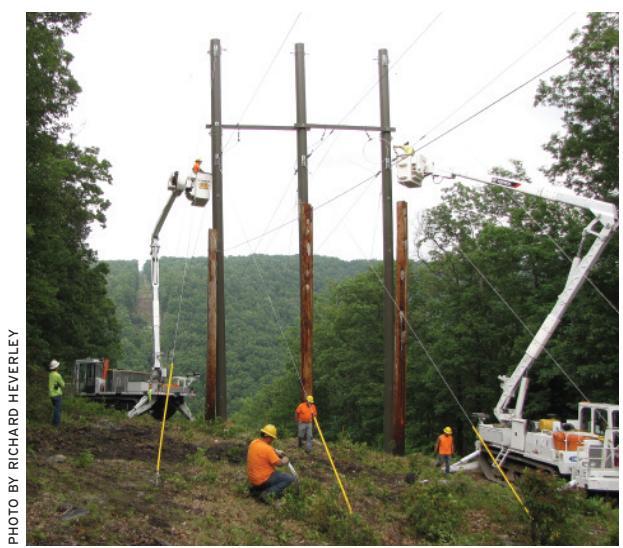
MORAVIAN RUN PROJECT NEARS COMPLETION: The new structure is completed and has been re-energized. The only thing left to do is to remove the bottom half of the wooden poles in front of the structure. If you look closely, you can see gray spots on the pole that are the patches we put in place earlier. All of the new woodpecker holes don't show up in this photo.

So even though his theory is unproven (but the most logical explanation), and even though vibration dampers didn't deter the woodpeckers on the wooden poles, Steve designed in vibration dampers on this project with the new "woodpecker-proof" fiberglass poles. On each conductor, on both ends of the crossing, there are some strange looking things with counter-balanced weighted balls that are supposed to stop or at least lessen the vibrations. With these in place, the woodpeckers, hopefully, will not waste their time or hurt themselves trying to come up with a way to get into the new poles. One thing I know I'm glad of (especially when I saw the huge hole they pecked in the pole in the photo with this article) is that I didn't have to listen to that woodpecker hammering away at that pole outside my bedroom window.
