Adsorption Clarifier[®] Retrofit Improves Plant Operations Westfield Updates Existing Trident[®] Package Plant

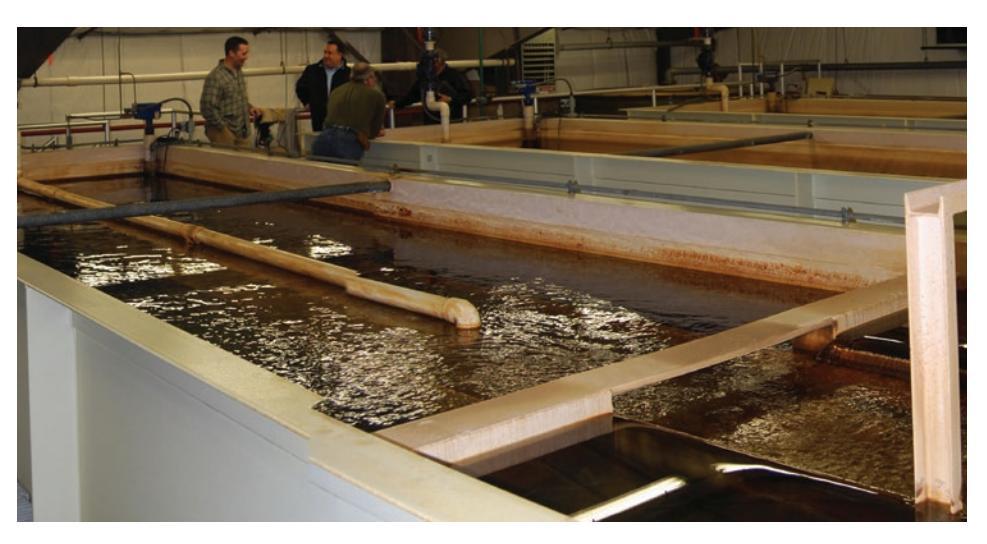
Twenty-one years in operation had taken a toll on the original system.

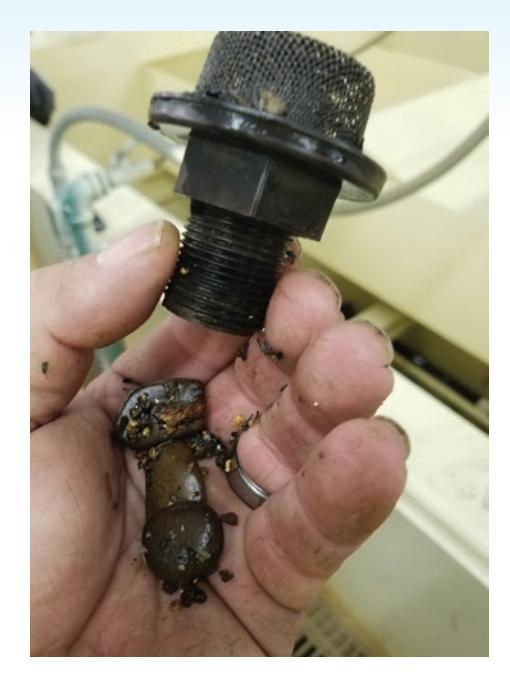
Replacing plugged Adsorption Clarifier nozzles enhanced performance.

- Replacing the plugged air nozzles in the Adsorption Clarifier compartment allowed the flush process to better clean the buoyant media across the entire bed.
- Upgrading the filter section with an air-water backwashing system improved the performance of the filters, providing a more rigorous and thorough bed turnover that releases more solids contained in the bed.

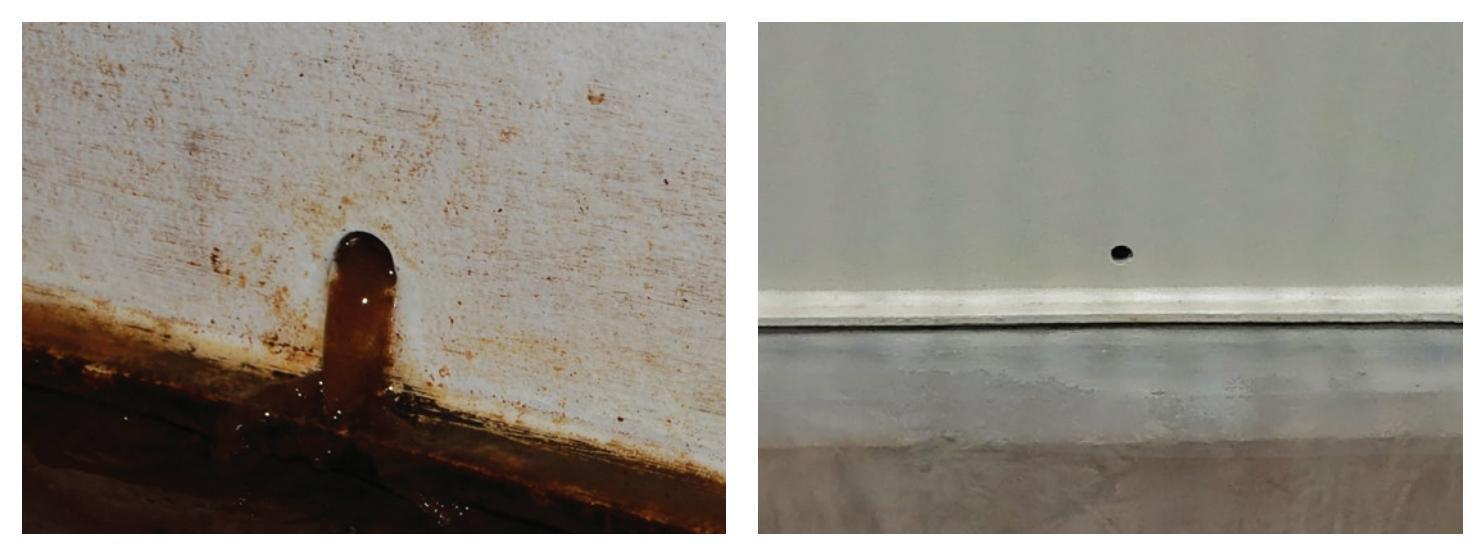
The first step was to find out why water and media were leaking from the weep holes on both sides of the double wall between a unit's clarifier and filter compartments. Applying air pressure through the openings while the filter and clarifier compartments were full of water revealed that the leak was coming from the clarifier compartment.

The plant's raw water averages from 10-20 NTU, with storm-related spikes up to 300-400 NTU. To reduce the turbidity, the plant feeds ferric chloride as a coagulant with cationic polymer and carbon. The raw water and chemistry, which contain abrasive particles, entered the Adsorption Clarifier compartment through a raw-water header and was constantly hitting the double wall between the clarifier and filter. Over the years, this had worn a hole through the first wall.

Normally 48 inches (1.2 meters) deep, Adsorption Clarifier media loss had reduced the actual bed depth to approximately 24 inches (0.6 meters), resulting in lower solids retention. Solids that should have been captured in the Adsorption Clarifier media were passing to the filter, resulting in short run times between backwashes.

The Adsorption Clarifier media coming out of the weep holes was indicative of media coated with a material that was not allowing it to retain its buoyancy. Finally, the unit's surface-only wash was not thoroughly cleaning the filter bed.

Adsorption Clarifier buoyant media had been leaking from the unit's weep hole.

Because the plant often operates two units with the third in standby, the implementation team opted to perform the upgrades sequentially, one unit at a time (always leaving two units operational). The repairs included replacing the Adsorption Clarifiers' media and inspecting their air distribution system. The team also repaired or replaced nozzles (as needed), static mixers, and filter inlet and effluent function valves.

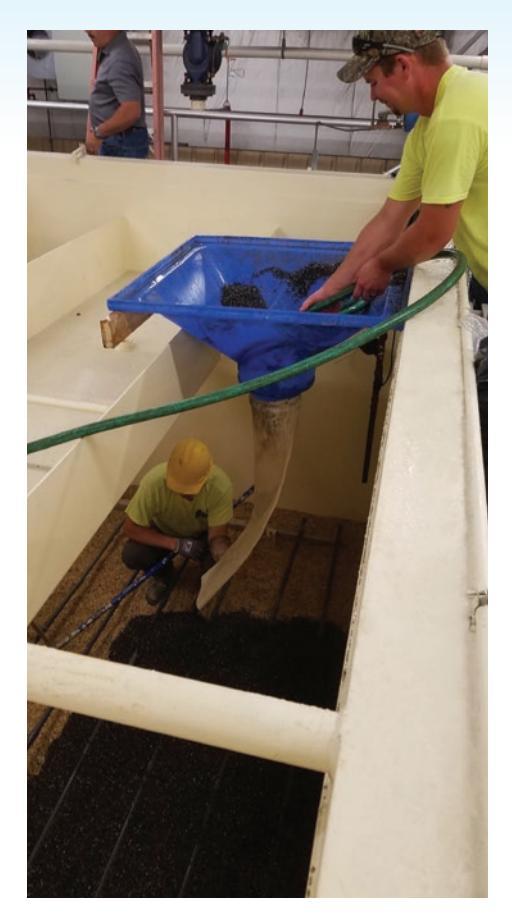
Filter bed media was installed atop the new in-bed air grid for air-water backwashing.

- Removing the existing surface wash arms, filter media, and support gravel
- Inspecting the existing header and lateral underdrain
- Replacing the support gravel
- Adding an in-bed air wash grid
- Replacing the filter media
- Adding (or replacing) the existing blowers
- Adding air scour valves

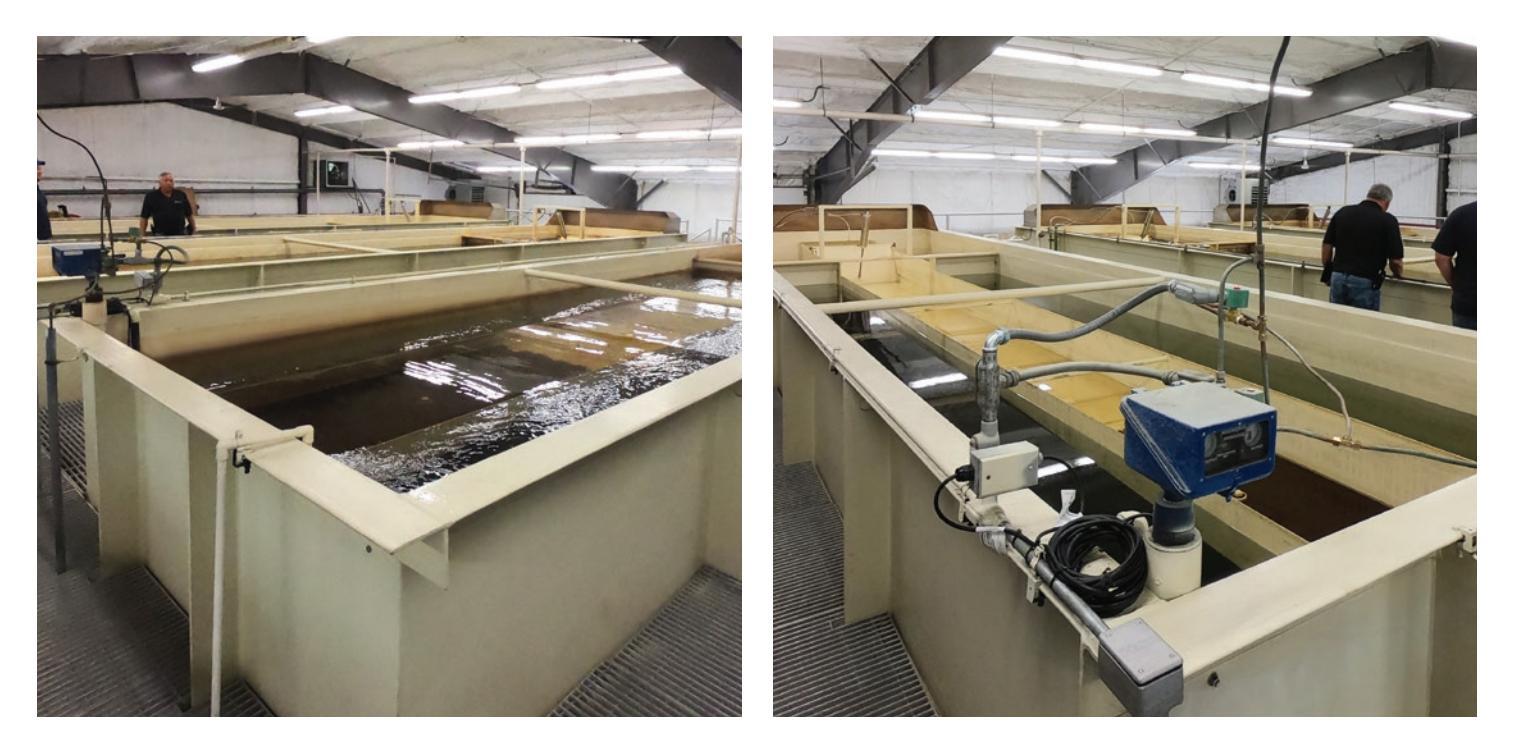
The plant repaired and painted the tanks during the repair-upgrade process. The three updated Westfield units are now in production.

While each unit was down, the plant repaired and repainted the tanks. It completed the repairs and upgrades in 2019.

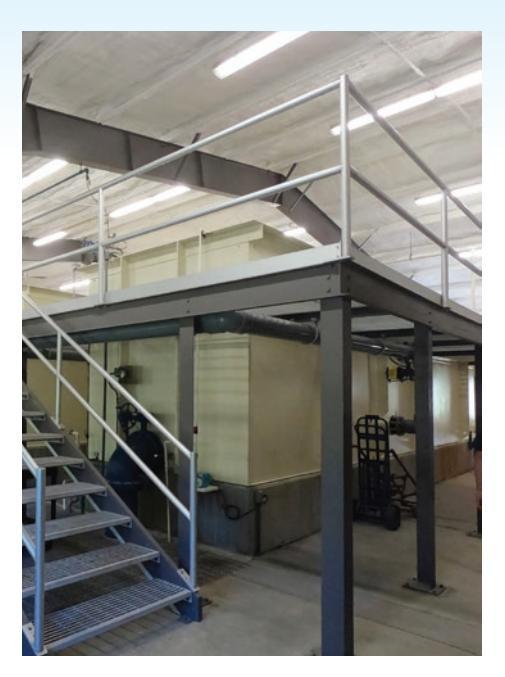
Simple but necessary upgrades to the Trident system improved plant efficiency.
