# Advanced Polymer Coatings Provides Tyndall AFB with Environmental Protection

**ChemLINE®**  
CASE STUDY

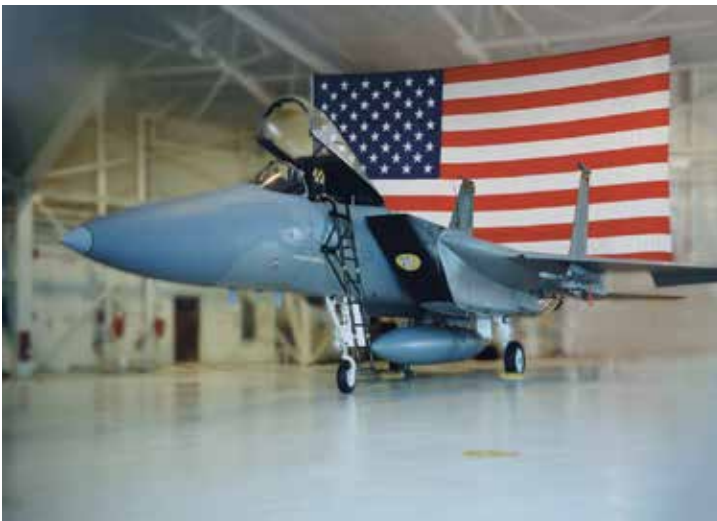
*Tyndall Air Force Base with the protective ChemLine® floor coating system.*

The major project then started as a crew completely removed the old floor coating by stripping and blasting with various shot-size combinations. Any cracks and loose concrete were removed and/or repaired, including filling the expansion joints with ChemLine® Caulk. All surfaces were then power washed at greater than 10,000 psig to remove all contaminants prior to coating.

The coating applications were done by spray, roll-on, brush and trowel as needed. Some areas required a coat of ChemLine® primer. This coating provided greater adhesion and a longer re-recoat window and was applied at a thickness of 3-5 mils. The ChemLine® primer helped fill in flooring deformities, such as pores in concrete to minimize outgassing. APC recommended that the ChemLine® coating be applied in two coats. The second was applied once the first was ‘firm to the touch’ and has just lost its tackiness. The full cure of the topcoat occurred in 5-7 days depending on the ambient temperature at the

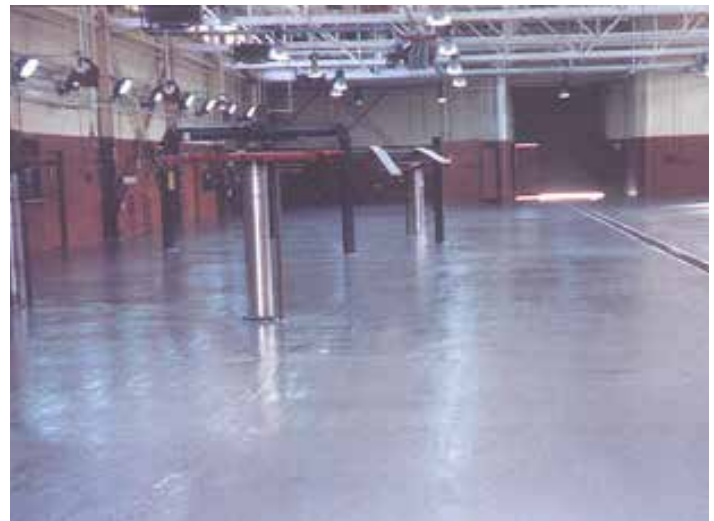
*Vehicle maintenance area with ChemLine® coating.*

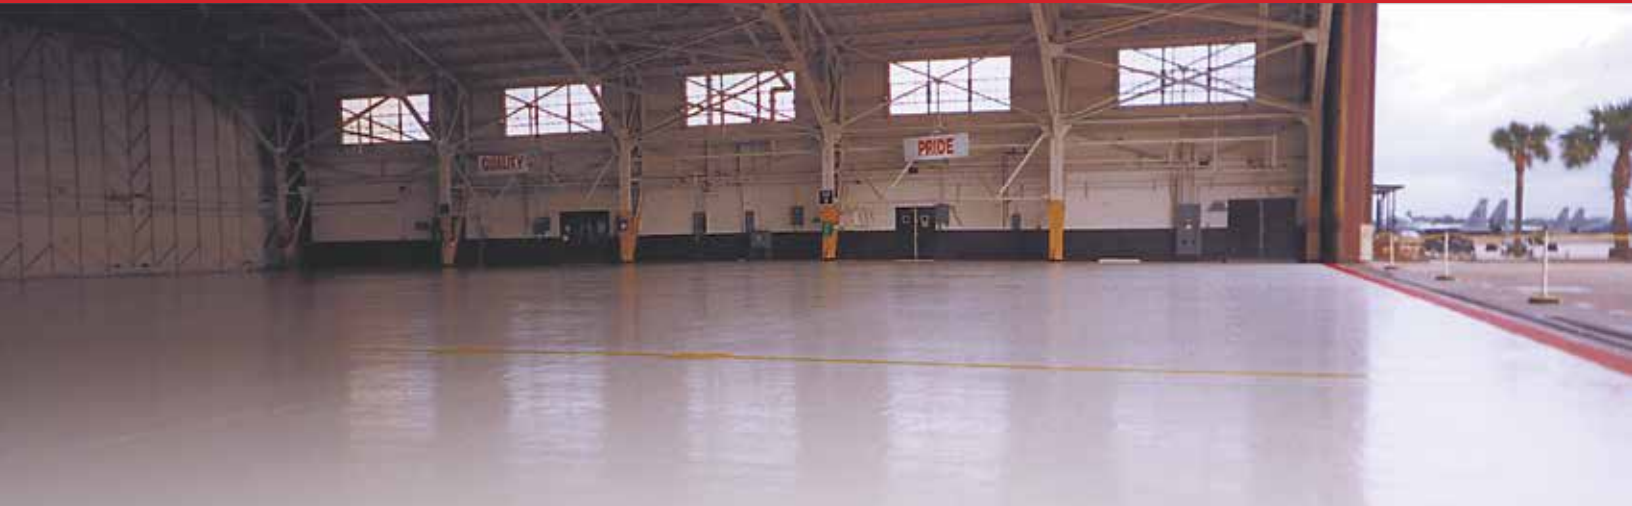
*After two years, the ChemLine®-coated floor still looks like new.*

The first floors completed over four years ago, according to the officer in charge “are performing above and beyond.” After two years of the most damaging service, problems have been almost non-existent. ChemLine® solved the problems of peeling and flaking, cracking and the need for constant repair. The 200,000 square feet of ChemLine®-treated floors have lived up to the promise. One supervisor adds, “The wear and tear problems have gone away and the use of metal tools, hoses, and equipment have had no effect on the floor. The skid-resistance surface is the best I have seen in 23 years.”

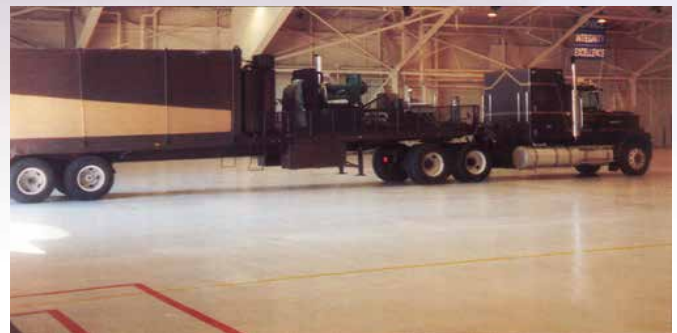
*Ultrahigh pressure wash blast at greater than 10,000 PSI does not damage ChemLine®.*
