Deep Bed™ Thickener in High Rainfall Area

Design Incorporates Benefits of Surface Stacking for Effective Water Management

CASE STUDY

Location: China
Owner: Anonymous

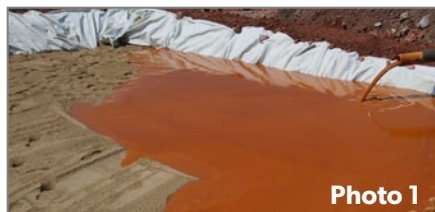
Photo 1

the installation of the paste thickener to quantify the benefits and refine the site management plan. A 10 m by 10 m test site was prepared next to the TSF and was filled to about 500 mm deep with P&TT. Due to the very fine PSD, this non-Newtonian underflow has the design yield stress at about 28-29 weight percent (wt%) solids (see Photo 1).

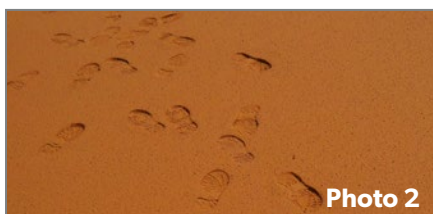
Photo 2

The rapid consolidation and drying allowed foot traffic by the fourth day, despite 15 mm of rain that day (photo 2). Drying continues quickly with large cracks developing by day seven (see photo 3). Day 10 shows the deposit after two rain events, dried to significant cracking. At this point about half of the water has evaporated (see photo 4).

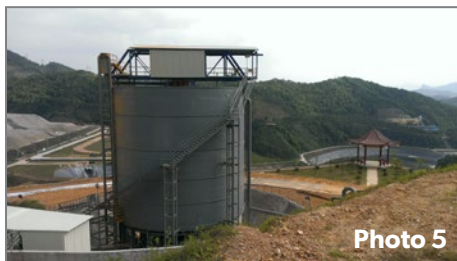
Photo 5

The installed 15 m diameter WesTech Deep Bed™ Paste Thickener on a hill near

the TSF (Photo 5) effectively dewateres to a non-Newtonian density, P&TT, and recovers clear water for recycling. The low-yield stress P&TT is pumped a short distance to the TSF by centrifugal pumps.

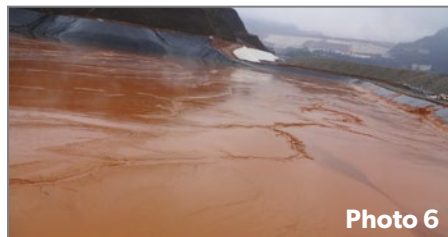
The initial spigots were placed along one side of the TSF, forcing the pond water from the previous pond slurry to collect near the dam where this water was recovered. The TSF had relatively no standing water after about three months of operation. Photo 6 shows the TSF during the first monsoon season.

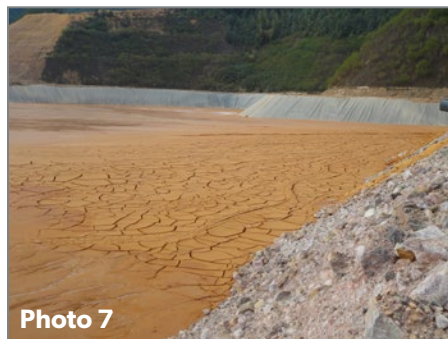
Photo 7

Once the water was collected, the spigot placement was shifted to other locations around the TSF, eventually settling on the arrangement of spigots located along the dam. Rotating active spigot locations allows drying between layers for stability (see photo 7). The gentle 1-3 percent deposition slope drains rain from the surface at mild velocities to minimize erosion of the solids and keep the solids exposed for continued air drying. The site management plan did not recover rain runoff collected in the TSF footprint but left it in the TSF to absorb and ultimately evaporate.

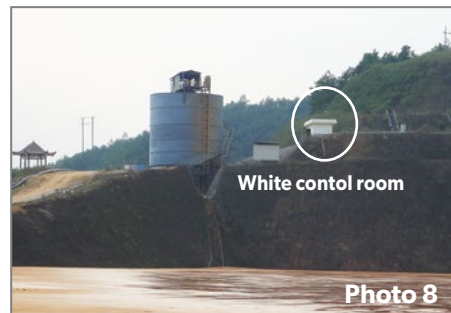
Photo 8

Over five years of operation, the dam elevation increased over 20 meters. Comparing photos 8 and 9, the white control room building can be used as an elevation reference. At this point, the TSF filled to capacity, encroaching on roadways and other facilities.

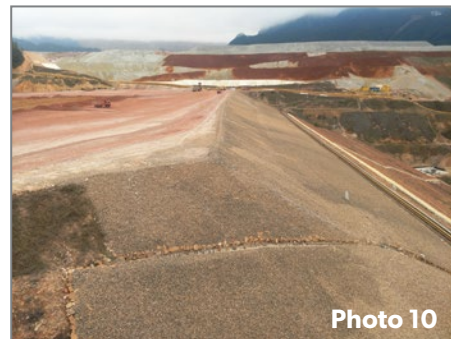
Photo 10

Rapid drying of the Deep Bed thickener underflow throughout the years allowed the plant to have quick access to the TSF once it was filled. The capping process quickly followed closure of the site (see photo 10).
