Mine's Innovative Process Succeeds With WesTech's Responsive, Customized Retrofit

CASE STUDY

Location: Western United States
Owner: Confidential

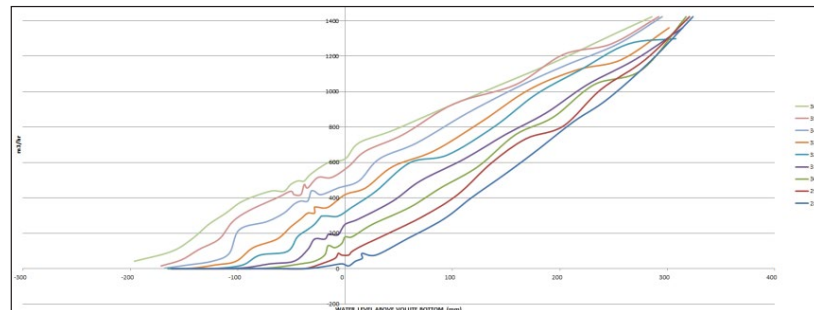
Analysis for Optimized Flow Characteristics and Throughput

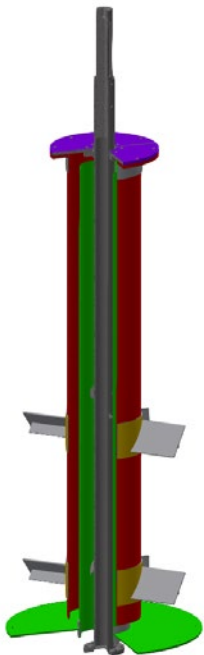
The first step was to replace the pulse blades on two existing interstage screens with wider blades that the engineer could adjust to reduce the space between the blades and the screen. The purpose of this step was to determine if the new blades alone could create enough force to reduce pegging in the interstage screens.

Lift-Assist Retrofit Using Blade Modification

The second step was to increase the rotations per minute (RPM) of the pulse blade to determine if increased force, in conjunction with the new pulse blades, could sufficiently reduce pinning.

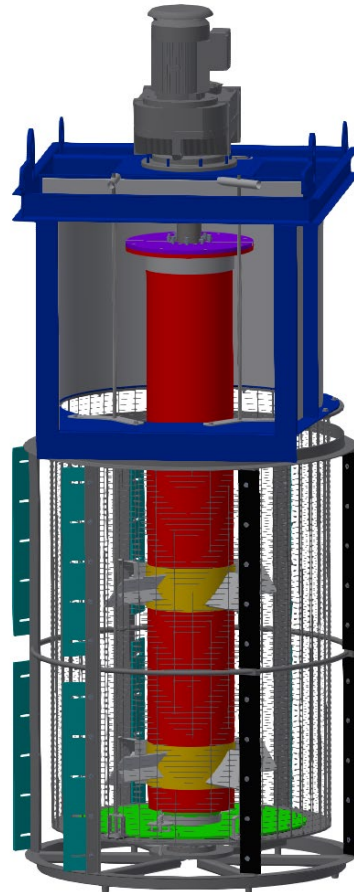
Lift-Assist Pumping Screen Design for the Mine's RIL/RIP Process

While the pumping screen WesTech designed through its initial R&D included a large conical pump, the engineer saw that for the U.S. mine, simply changing the shape of the impeller and increasing the rotational speed could provide the balance of agitation and pressure that the mine needed to improve throughput.

The modified impeller causes an agitation that makes the fluid flow upward without pumping it. Increasing the speed with this impeller-blade design allows more backwashing, automatically clearing the screen baskets that were prone to pinning. The modified impeller also added a slight vector of flow.

The retrofit design included a cage that rotates at the same speed as the impeller. The cage has blades that, with the correct placement, create a pressure pulse on the basket screens that helps pull away pinned media so that fluid can flow through.

In addition to the lift-assist pumping mechanism, the engineer replaced the company's existing basket screens. The replacement screens featured gaps that were optimized to work with the mine's specific RIL/RIP process. The basket-screen redesign also included reinforced backer rods to mitigate wear caused by increased loads.
