# AQUAFACTS

SPRING 2021 | THE OFFICIAL PUBLICATION OF THE NEW YORK RURAL WATER ASSOCIATION

# CASE STUDY: VILLAGE OF WESTFIELD UPDATES EXISTING WATER TREATMENT PACKAGE PLANTS TO IMPROVE OPERATION

Chris Rettig, Richard Ross, P.E. & Jayme Tuomala

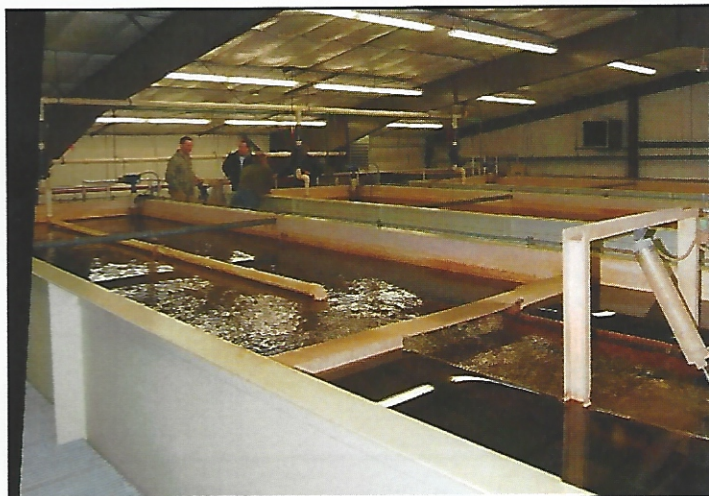
**Figure 1** Twenty-one years in operation had taken a toll on the original system.

By 2016, the current plant managers – Erin Schuster and Andrew Thompson – realized that years of use had taken a toll on the system's performance. Knowing that WesTech had made several advancements to the Trident system over the years, the two managers determined that the plant would benefit from repairs and updates to the latest Trident technology.

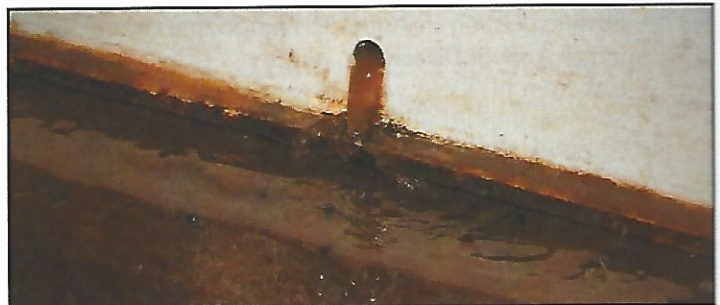
**Figure 2** Adsorption Clarifier buoyant media had been leaking from the unit's weep hole.

The first step was to find out why water and media were leaking from the weep holes on both sides of the double wall between a unit's clarifier and filter compartments. Applying air pressure through the openings while the filter and clarifier compartments were full of water revealed that the leak was coming from the clarifier compartment.

The plant's raw water averages from 10-20 NTU, with storm-related spikes up to 300-400 NTU. To reduce the turbidity, the plant feeds ferric chloride as a coagulant with cationic polymer and carbon. The raw water and chemistry, which contain abrasive particles, entered the Adsorption Clarifier compartment through a raw-water header and was constantly hitting the double wall between the clarifier and filter. Over the years, this had worn a hole through the first wall.

Normally 48 inches (1.2 meters) deep, Adsorption Clarifier media loss had reduced the actual bed depth to approximately 24 inches (0.6 meters), resulting in lower solids retention. Solids that should have been captured in the Adsorption Clarifier media were passing to the filter, resulting in short run times between backwashes.

The Adsorption Clarifier media coming out of the weep holes was indicative of media coated with a material that was not allowing it to retain its buoyancy. Finally, the unit's surface-only wash was not thoroughly cleaning the filter bed.

Based on data and analysis, the plant opted to repair or replace worn components and upgrade the older surface washers, which were followed by a water-only backwash, with the air-water backwash technology available in current Trident units.

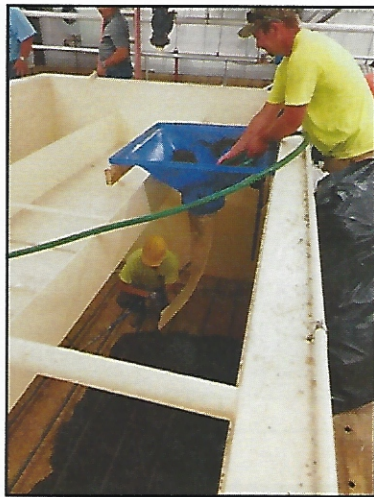
**Figure 3** Filter bed media was installed atop the new in-bed air grid for air-water backwashing

- Removing the existing surface wash arms, filter media, and support gravel
- Inspecting the existing header and lateral underdrain

- Replacing the support gravel
- Adding an in-bed air wash grid
- Replacing the filter media
- Adding (or replacing the existing) blowers
- Adding air scour valves

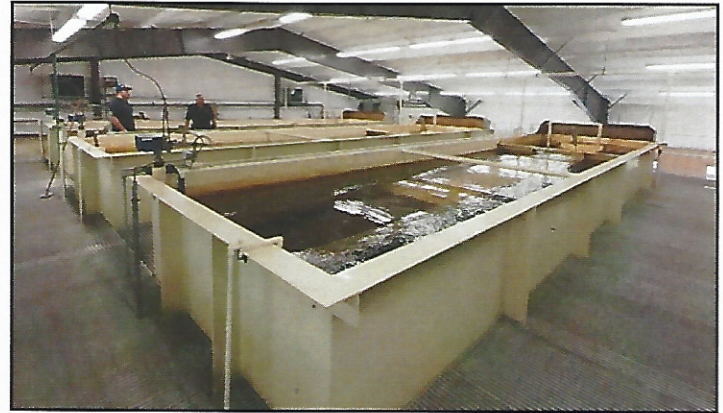
**Figure 4** The plant repaired and painted the tanks during the repair-upgrade process.

While each unit was down, the plant repaired and repainted the tanks. It completed the repairs and upgrades in 2019.

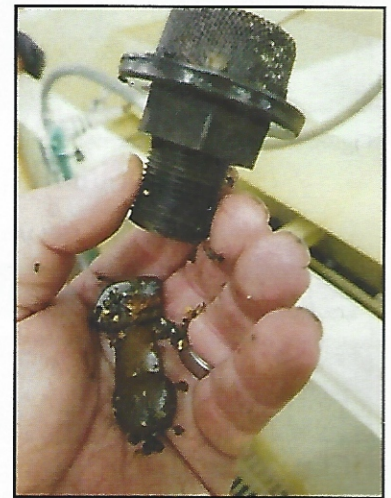
**Figure 5** Replacing plugged Adsorption Clarifier nozzles enhanced performance

- Replacing the plugged air nozzles in the Adsorption Clarifier compartment allowed the flush process to better clean the buoyant media across the entire bed.
- Upgrading the filter section with an air-water backwashing system improved the performance of the filters, providing a more rigorous and thorough bed turnover that releases more solids contained in the bed. >>>
