Case Study

Aquinas Catholic College (Menai, NSW)

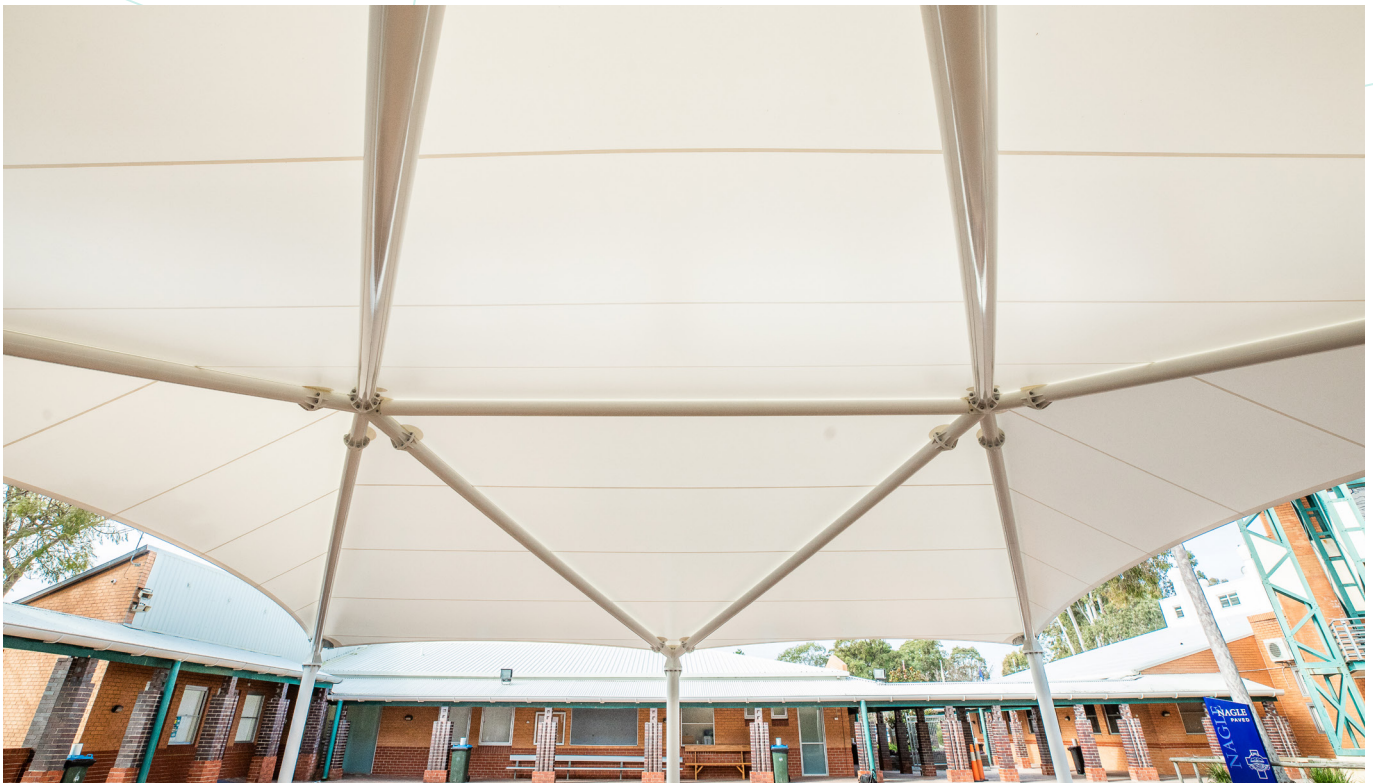
The existing fabric structure at Aquinas College had problematic 'waterproof' shade fabric (pictured below). The fabric had the weight and tension of shade cloth but with a waterproof coating. It was sewn, which meant it had holes in the seams (causing leaks), and also it needed to be installed in a particular way to avoid UV damage to the laminated coating. Unfortunately, this trapped water in the shade cloth and led to very rapid build-up of mould. The college needed a design and construct partner who could remove the existing structure and replace it with a correctly engineered waterproof structure.

We designed and built a new waterproof structure covering the same footprint but with a suitably engineered frame and proper PVC waterproof membrane. To overcome the access issue, the team craned the existing structure out, the rock coring machine in, and then the new structure – all over the top of the existing two-story school buildings.
