SALAMANDER INSPECTIONS LTD

Mechanical Insulation Energy Audits

Energy Audit

University of the Fraser Valley

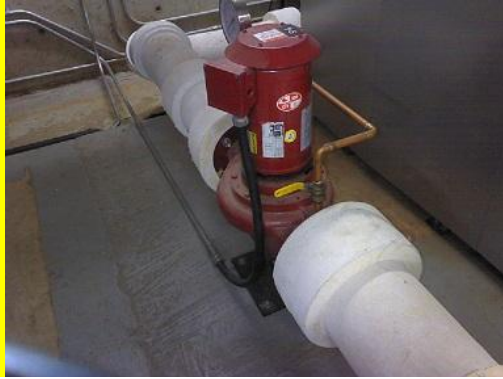
Figure 4 This is a conventional photo of the same pump.

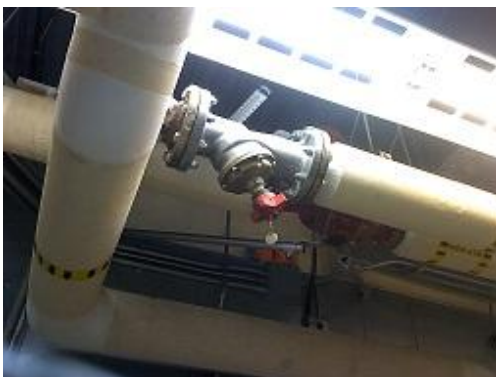
Figure 28 Conventional image of same control valve.

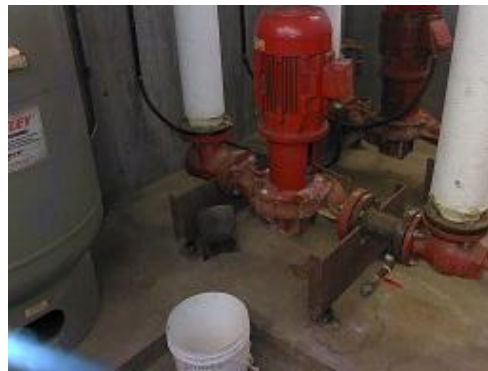
Figure 44 Conventional image of the same pump.

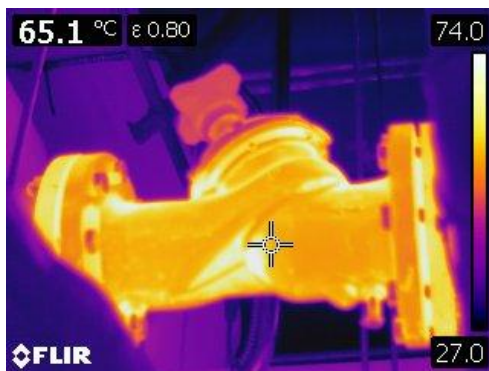
Figure 45 Thermographic image of exposed control valve.

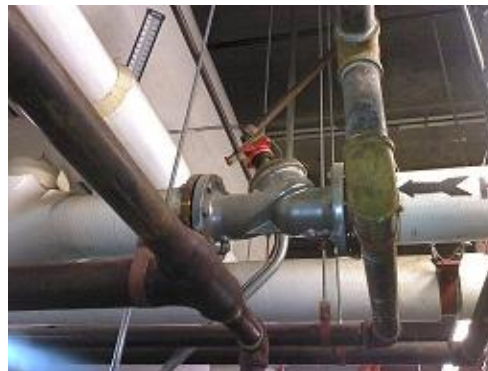
Figure 46 Conventional image of the same valve.

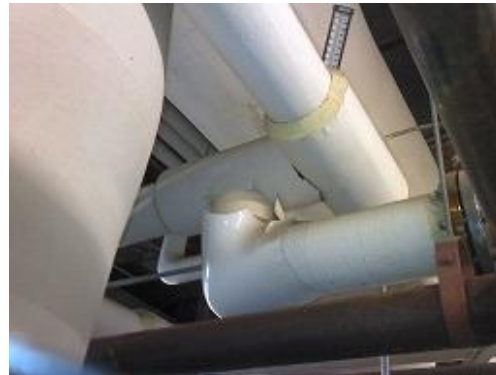
Figure 48 Conventional image of the same pipe covering and elbow with heat loss at intersection of materials.

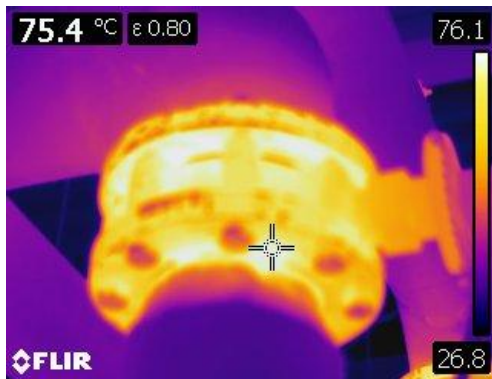
Figure 49 Thermographic image of bare gate valve operating at 75.4C or 167F.

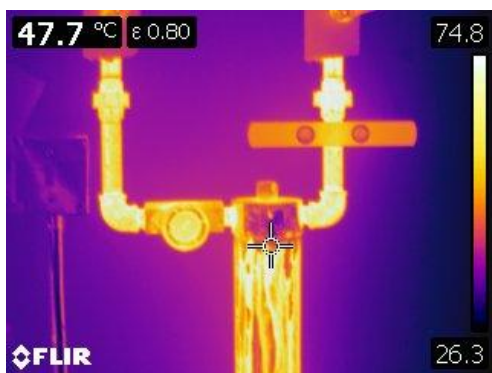
Figure 51 Thermographic image of chem. pot and piping.

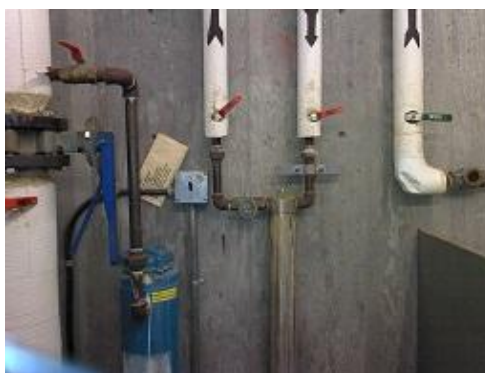
Figure 52 Conventional image of chem pot and piping.

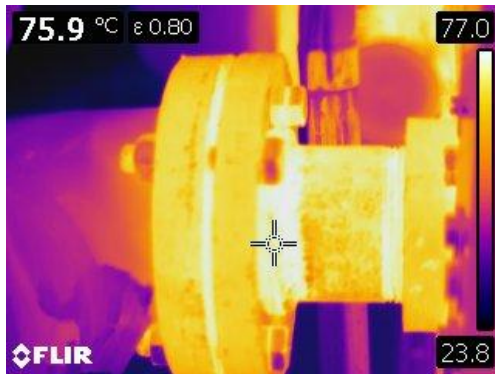
Figure 53 Thermographic image of exposed flanges at the back of the boiler

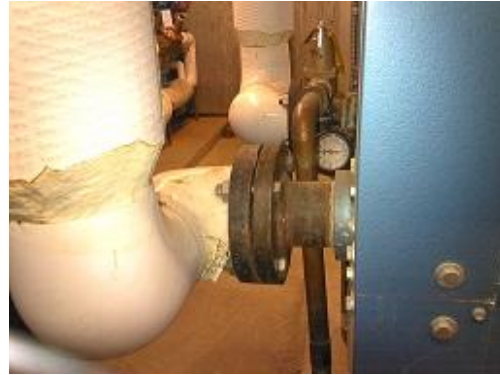
Figure 54 Conventional image of exposed flanges.

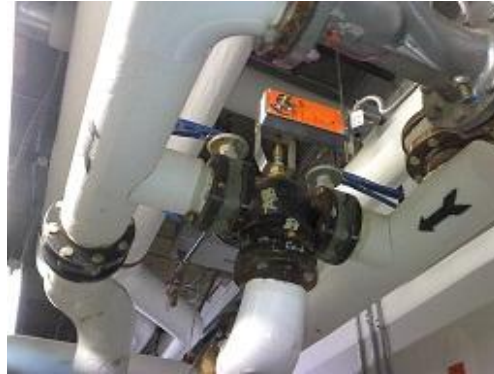
Figure 58 Conventional image of exposed three way valve.

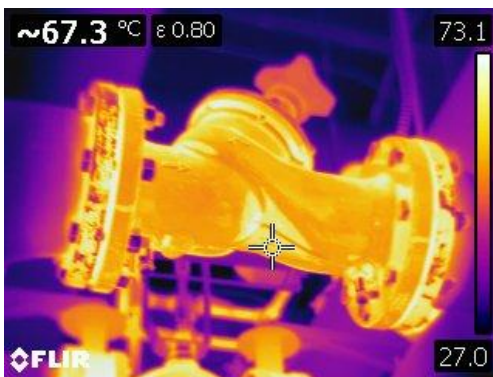
Figure 55 Thermographic image of exposed control valve.

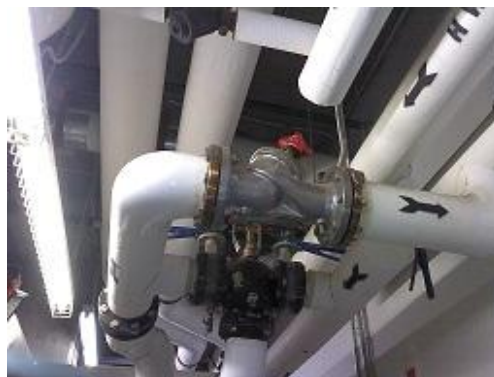
Figure 56 Conventional picture of exposed control valve.

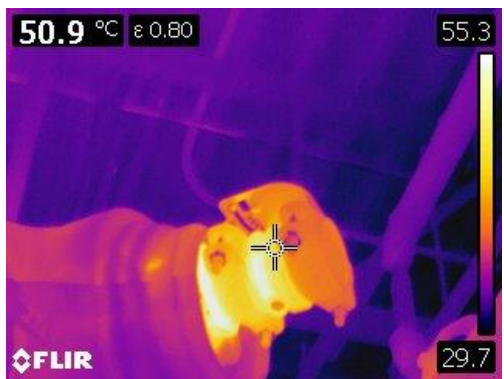
Figure 83 thermographic image of unfinished heating piping.
