SALAMANDER INSPECTIONS LTD

Mechanical Insulation Energy Audits

Energy Audit

Nanaimo Regional Hospital

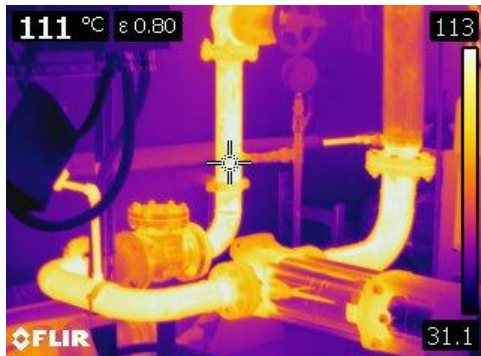
Figure 3 This thermographic image of exposed pumps and pipe at 111° C or 230° F.

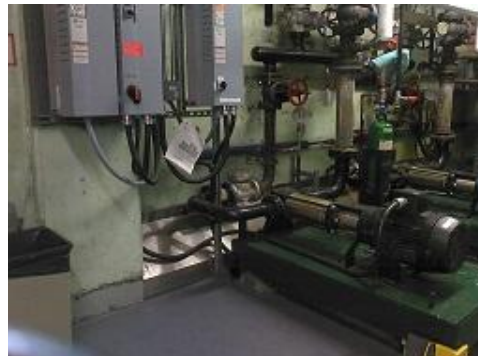
Figure 4 This is a conventional photo of the same pumps and piping.

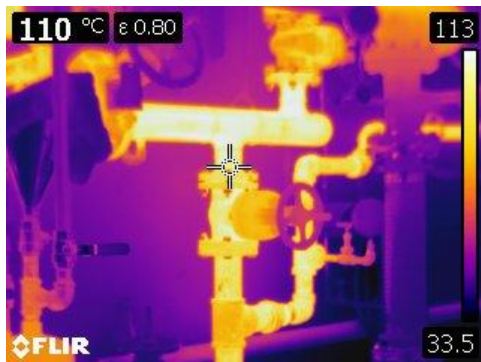
Figure 5 This thermographic image of piping and valves without insulation applied at 110° C or 230° F.

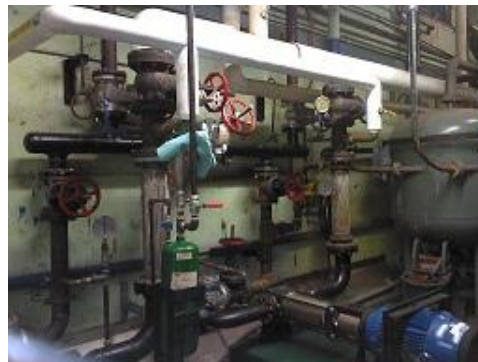
Figure 6 This conventional photo shows the same piping and valves.

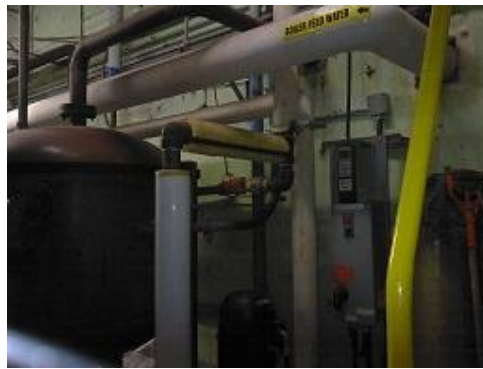
Figure 8 This is a conventional photo of the same piping and valve.

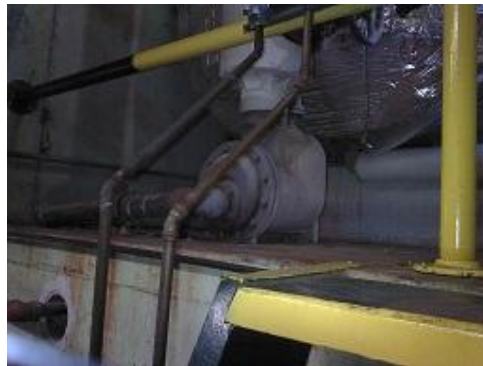
Figure 10 This is the conventional image of the same bare steam trap and piping.

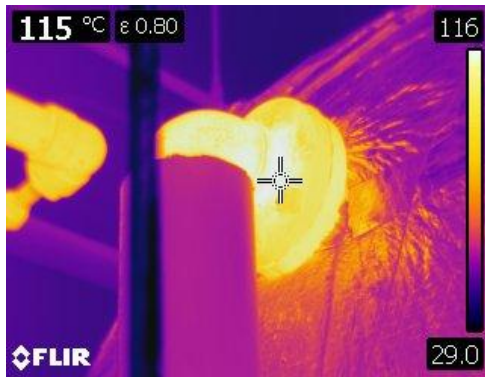
Figure 13 Thermographic image of a bare flange to tank at 115° C or 239° F.

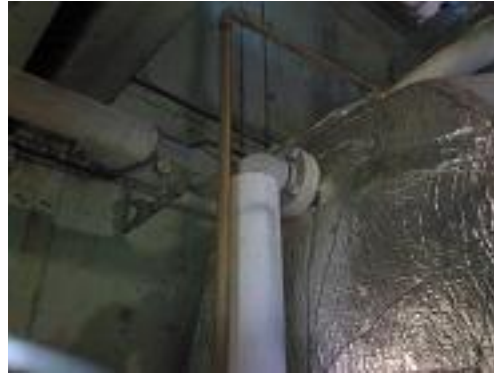
Figure 14 Conventional image of the same flange and piping at tank.

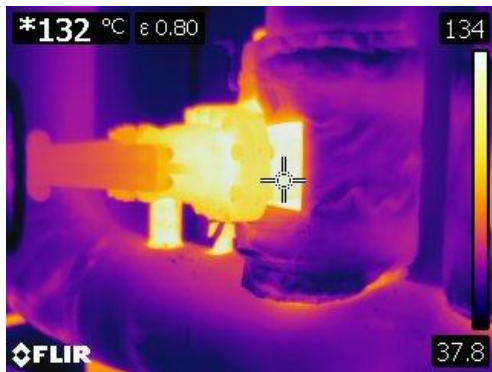
Figure 15 This thermographic image is of bare valve bonnets at 132° C or 269° F

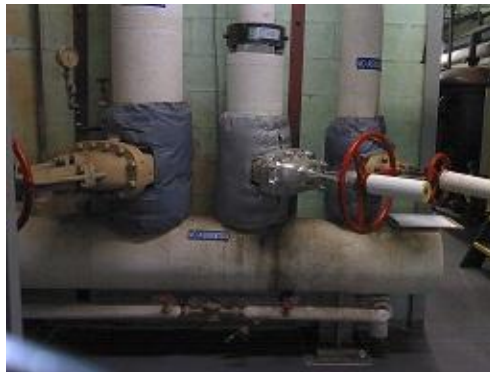
Figure 16 Conventional image of the same valve bonnets.

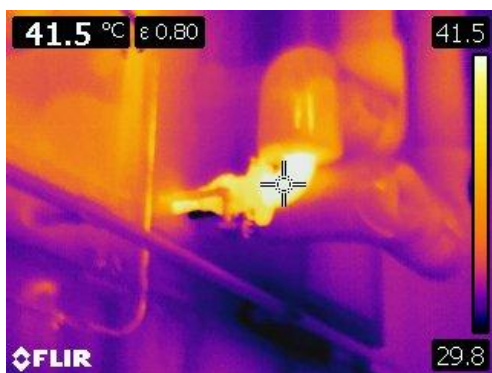
Figure 17 Thermographic image of unfinished elbows and fittings on new unit at 41.5° C or 106° F

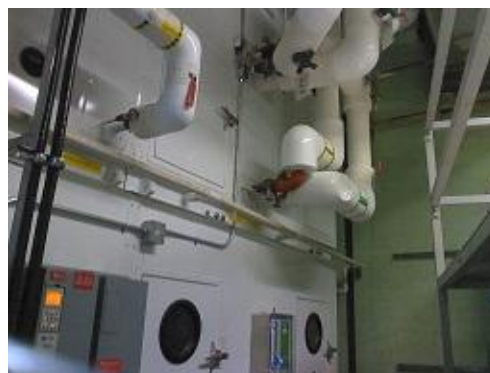
Figure 18 Conventional image of the same elbows and fittings.

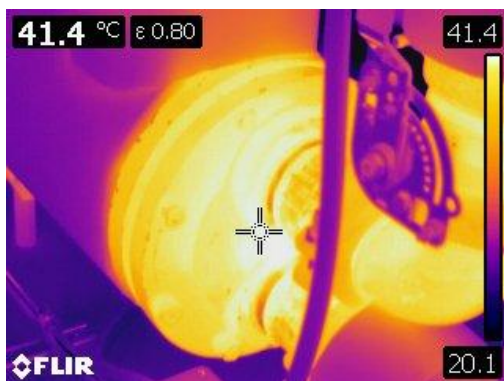
Figure 21 Thermographic image of the heat exchanger head at 41.4° C or 106° F.

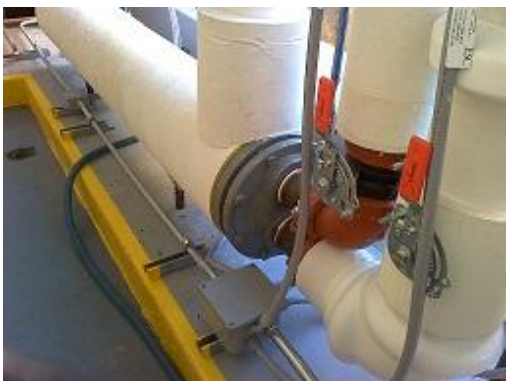
Figure 22 Conventional image of the same heat exchanger head.

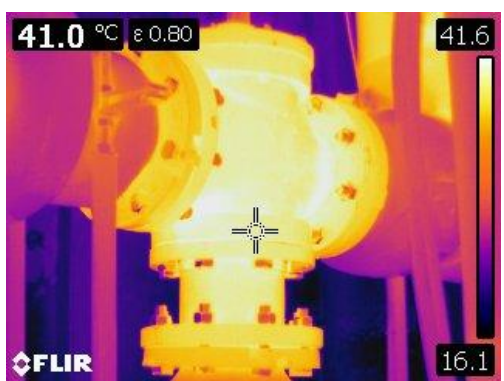
Figure 23 Thermographic image of a three way mixing valve at 41° C or 106° F.

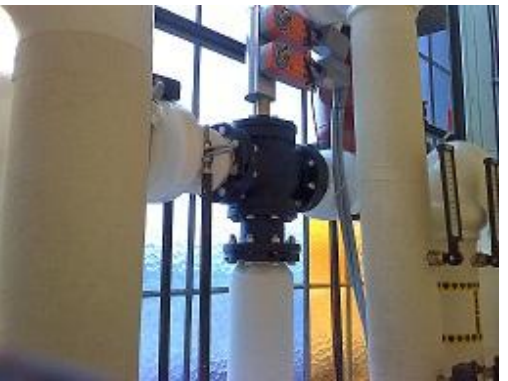
Figure 24 Conventional image of the same valve above heat exchanger.

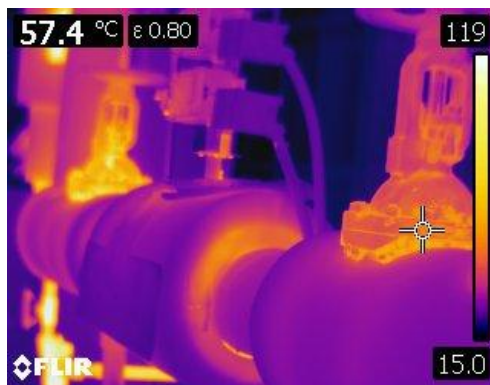
Figure 27 Thermographic image of valve bonnets and piping at 57.4° C or 135° F.
-note the heat loss under PVC fitting.

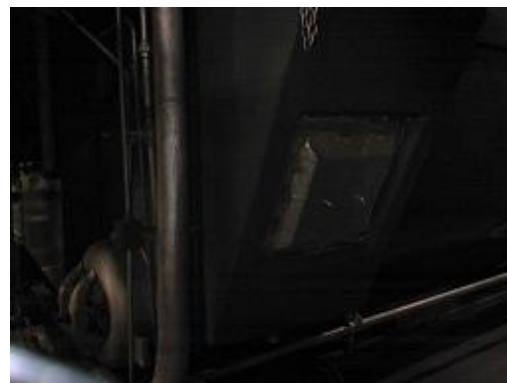
Figure 30 Conventional image of the same access door.

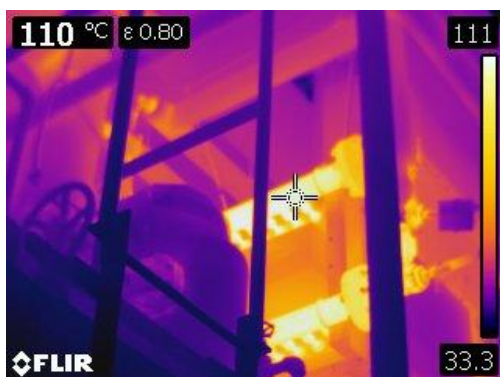
Figure 33 Thermographic image of bare piping at top of boiler at 110° C or 230° F.

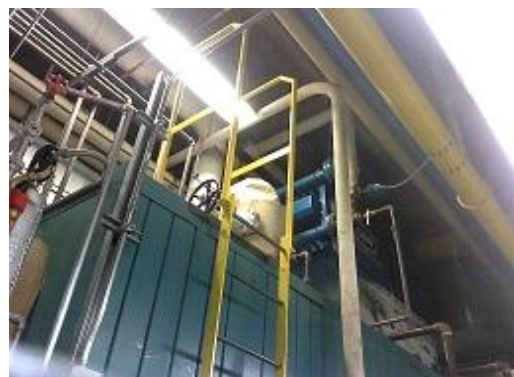
Figure 34 Conventional image of the same piping.

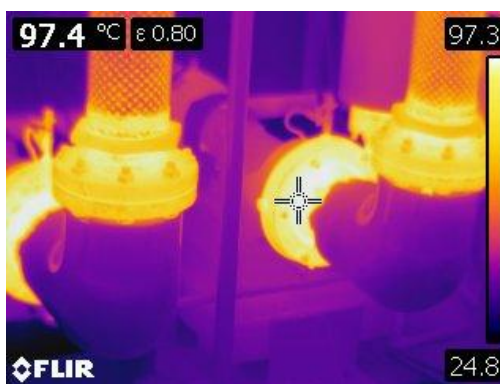
Figure 35 Thermographic image of bare pumps and flanges at 97.4° C or 207° F.

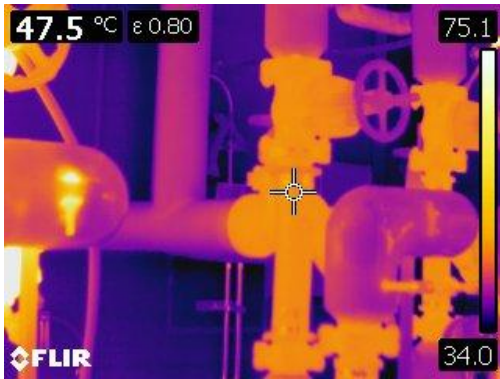
Figure 37 Thermographic image of valves, pumps and piping at 47.5° C or 117° F.

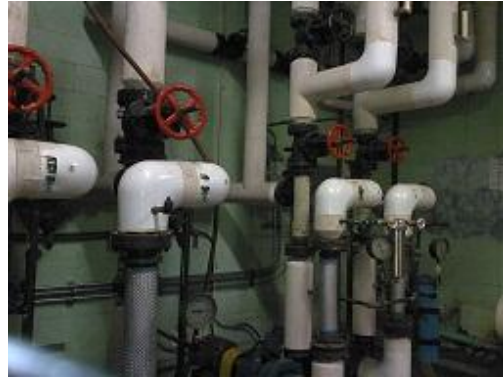
Figure 38 Conventional image of the same valves, pumps and piping.

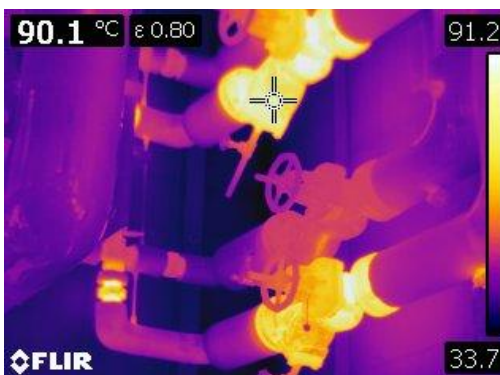
Figure 41 Thermographic image of bare valves and fittings at 90.1° C or 194° F.

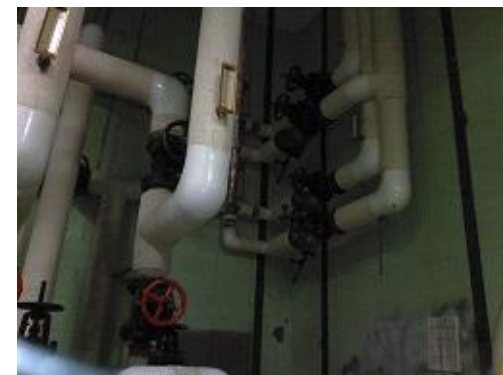
Figure 42 Conventional image of bare valves and fittings.

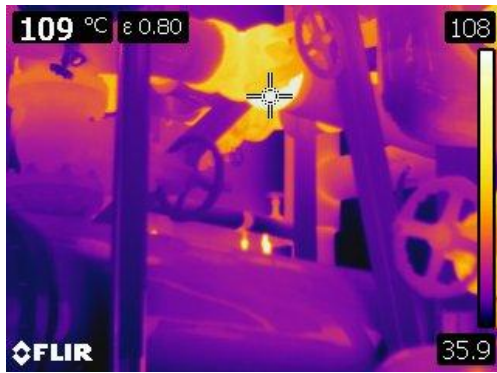
Figure 43 Thermographic image of bare valves above heat exchanger at 109° C or 228° F.

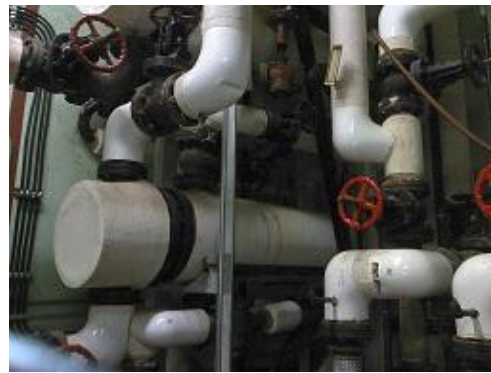
Figure 44 Conventional image of the same valves above heat exchanger.

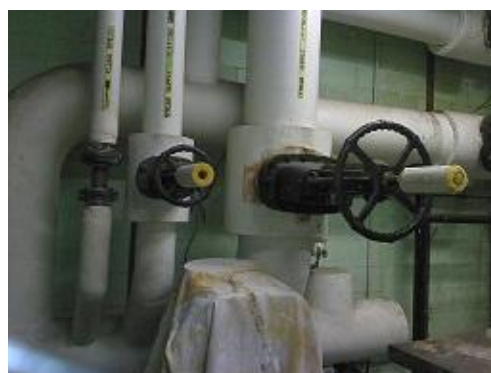
Figure 48 Conventional image of bare vane bonnets.

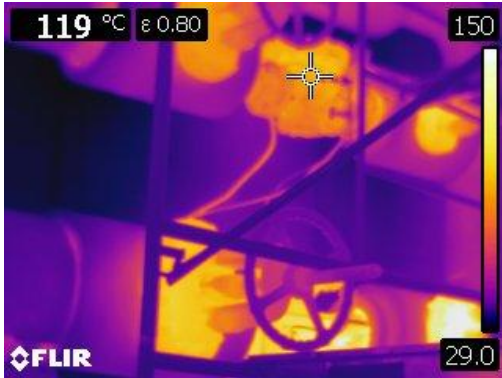
Figure 49 Thermographic image of bare valve bonnets and a pressure reducing valve at 119° C or 246° F

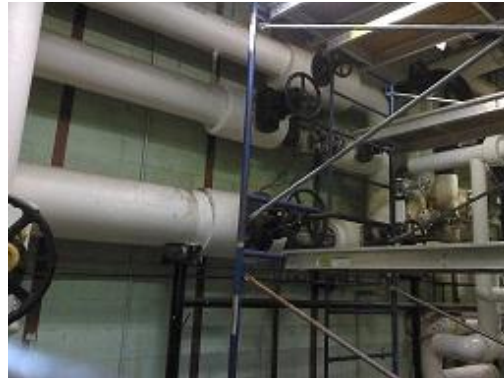
Figure 50 Conventional image of valve bonnets and pressure reducing valve.

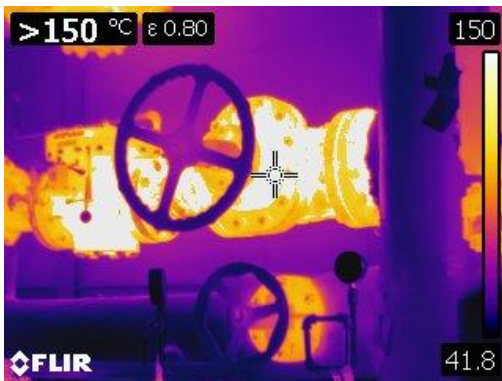
Figure 51 Thermographic image of bare valves at 150° C or 302° F

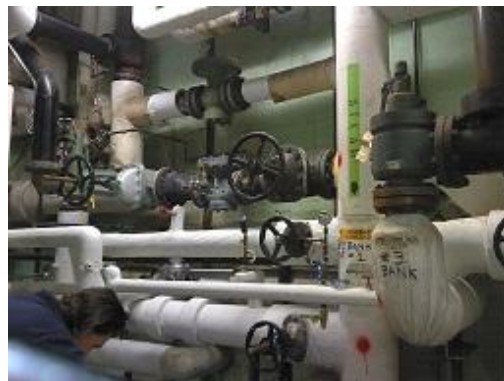
Figure 52 Conventional image of the same bare valves.

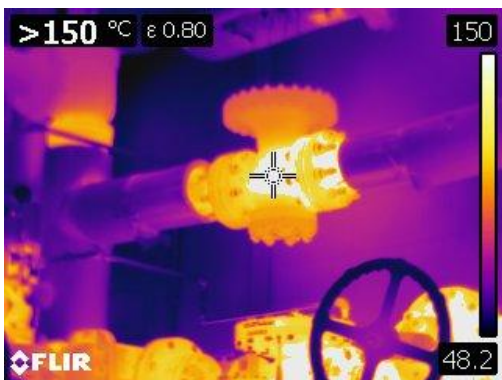
Figure 53 Thermographic image of pressure reducing valve at 150° C or 302° F

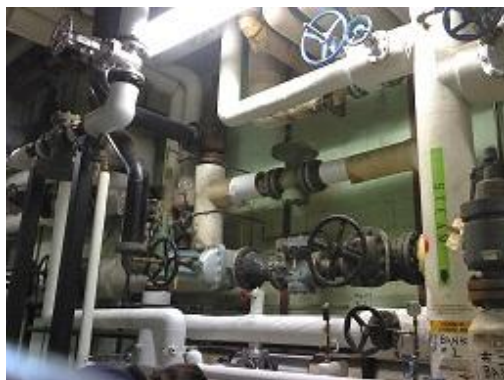
Figure 54 Conventional image of the same pressure reducing valve and other items.

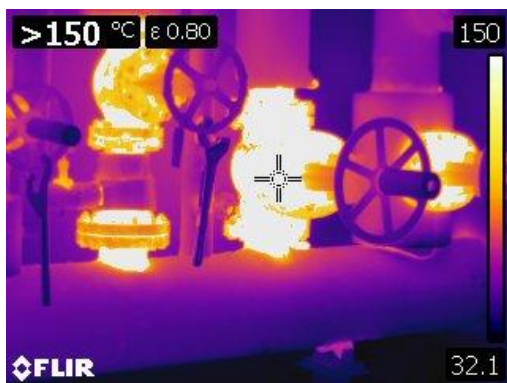
Figure 55 Thermographic image of bare valves on steam header at 150° C or 302° F

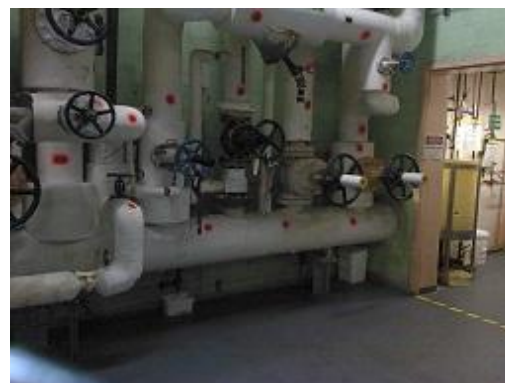
Figure 56 Conventional image of the same header and bare valves.

There are a number of items that are identified in this report that need to be addressed because of their high temperature. At the time of this inspection maintenance personnel were measuring some of the large bore valves for removable high temp insulating pads.

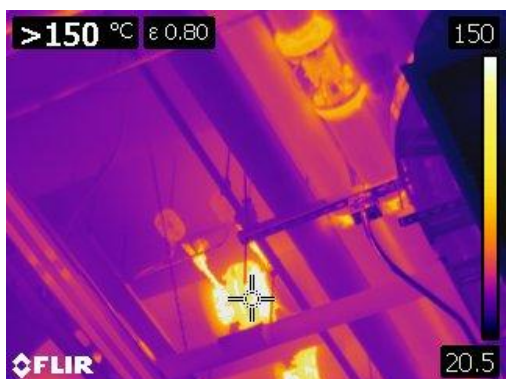
Figure 57 Thermographic image of bare flanges at 150° C or 302° F

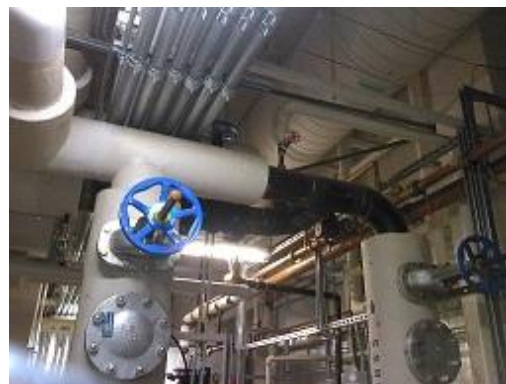
Figure 61 Thermographic image of bare 6 inch heating supply pipe at 70.9° C or 159° F

Figure 62 Conventional image of the same heating supply pipe.

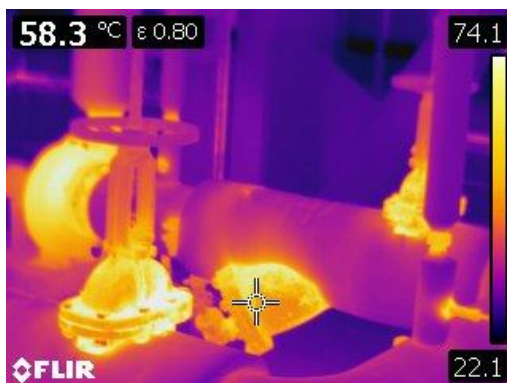
Figure 63 Thermographic image of bare valves bonnets and strainers at 58° C or 136° F

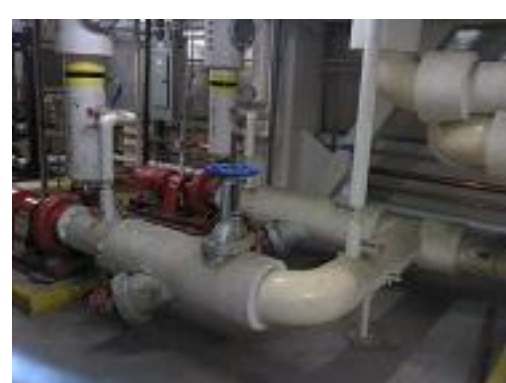
Figure 64 Conventional image of the same valve bonnets and strainers.

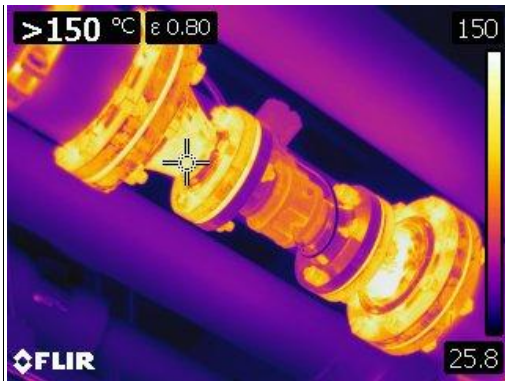
Figure 71 Thermographic image of a bare flow meter and flanges at 150° C or 302° F

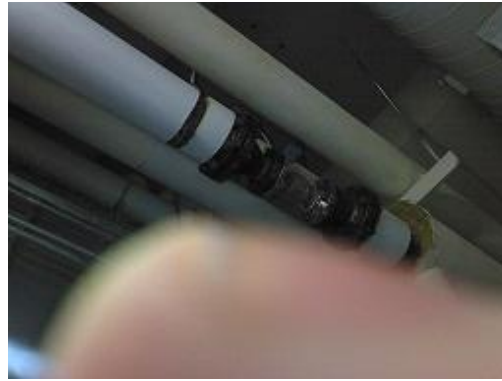
Figure 72 Conventional image of the same flow meter and flanges.

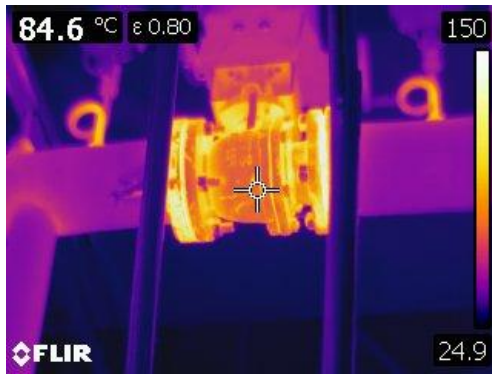
Figure 77 Thermographic image of a bare valve at 84.6° C or 184° F

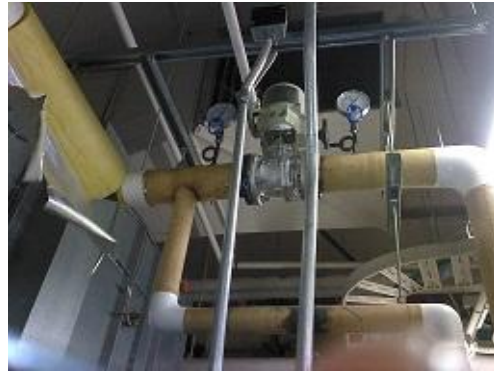
Figure 78 Conventional image of the same bare heating valve.

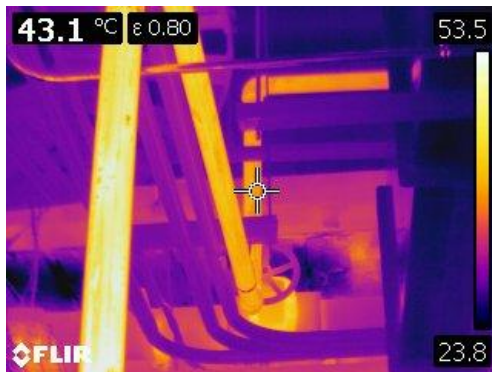
Figure 79 Thermographic image of a bare steel 2 inch line at 43.1° C or 109° F

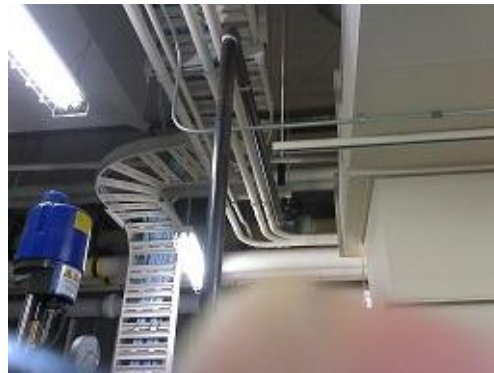
Figure 80 Conventional image of the same bare steel line.

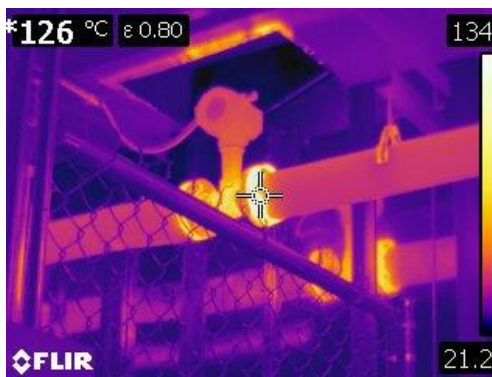
Figure 81 Thermographic image of 2 flow meters at 126° C or 258° F

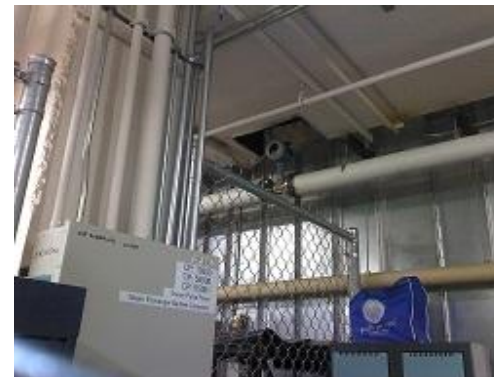
Figure 82 Conventional image of the same bare flow meters.

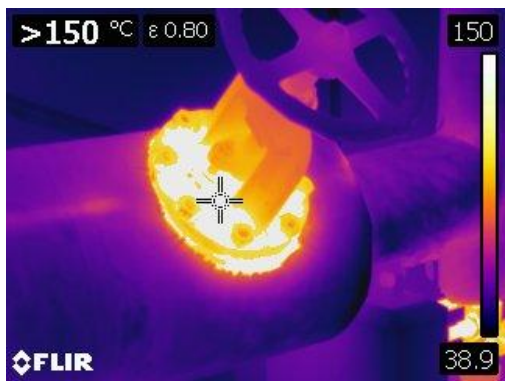
Figure 91 Thermographic image of bare valve bonnet on steam line at 150° C or 302° F

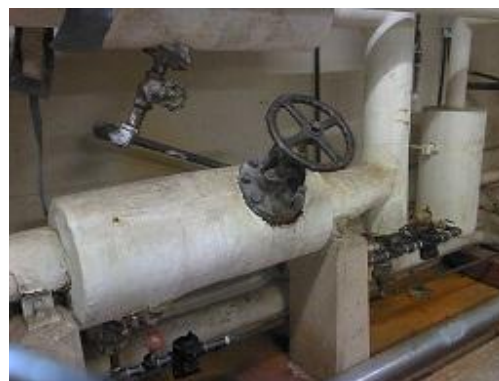
Figure 92 Conventional image of the valve bonnet.

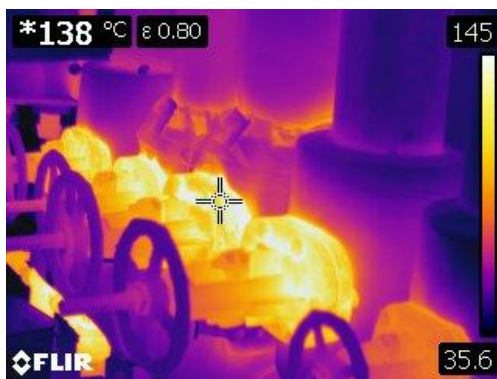
Figure 95 Thermographic image of bare valve bonnets on steam line at 138° C or 280° F

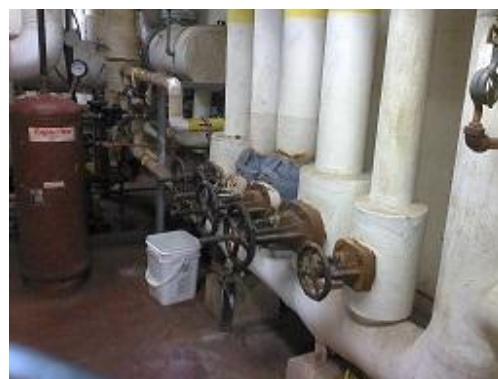
Figure 96 Conventional image of six (6) valve bonnets.

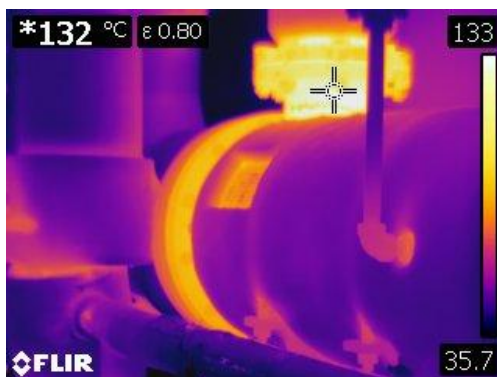
Figure 97 Thermographic image of heat exchanger flange at 132° C or 269° F

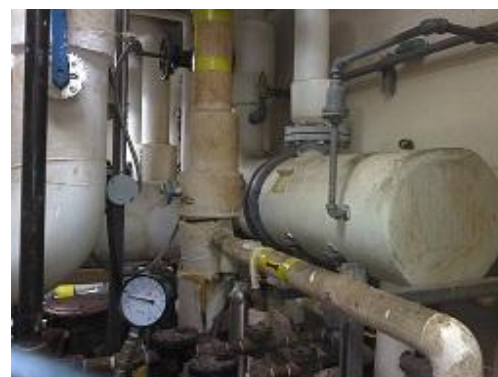
Figure 98 Conventional image of same heat exchanger flange.

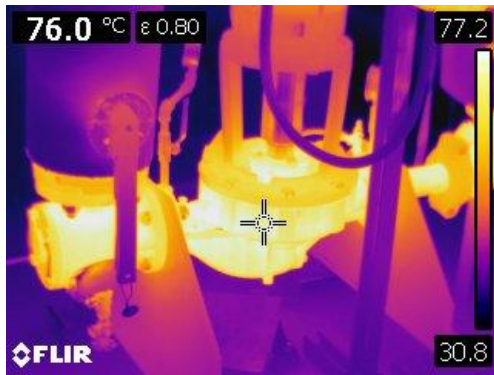
Figure 99 Thermographic image of a motorized heating pump at 76° C or 168° F

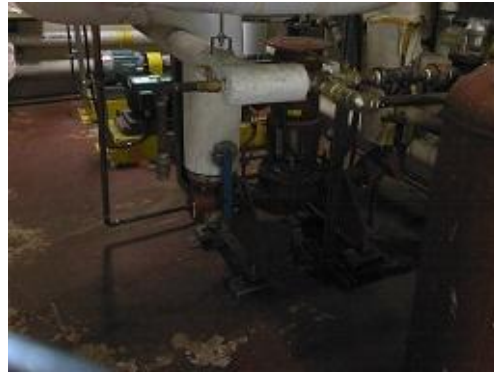
Figure 100 Conventional image of motorized heating pump.

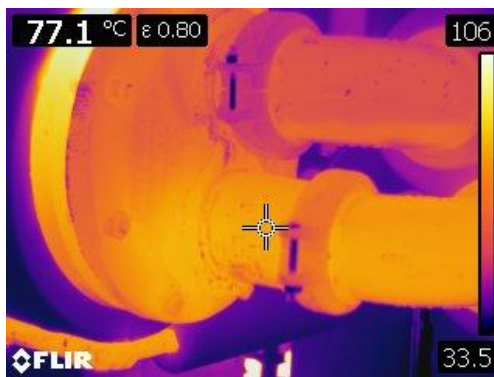
Figure 101 Thermographic image of heat exchanger head and piping at 77.1° C or 170° F

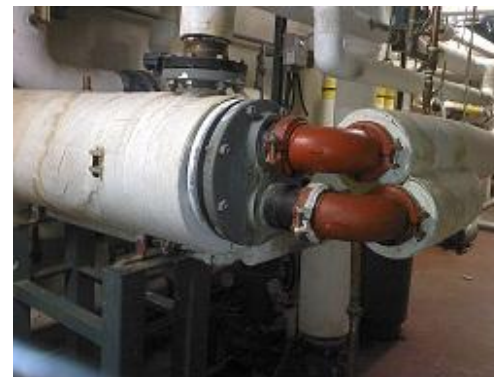
Figure 102 Conventional image of the heat exchanger head and piping.

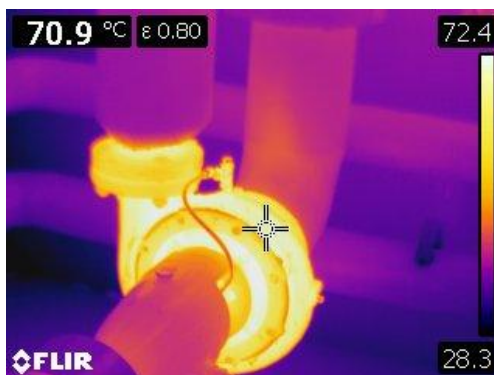
Figure 103 Thermographic image of motorized pump at 77.1° C or 170° F

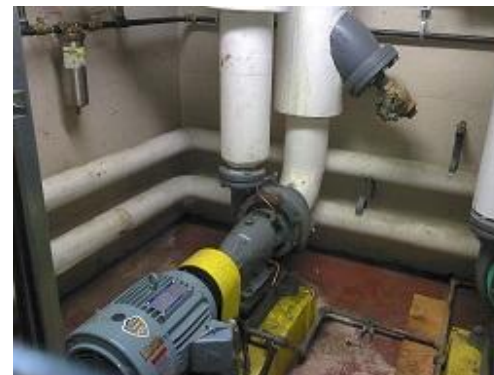
Figure 104 Conventional image of (2) motorized pumps.

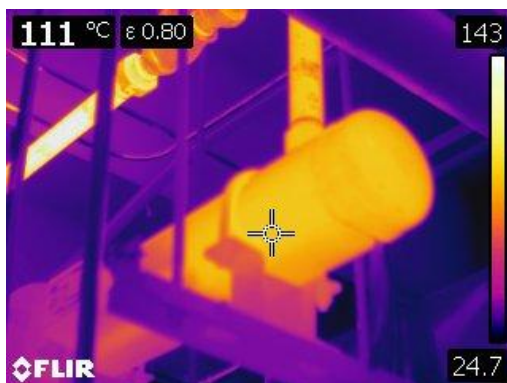
Figure 109 Thermographic image of a small heat exchanger at 111° C or 231° F

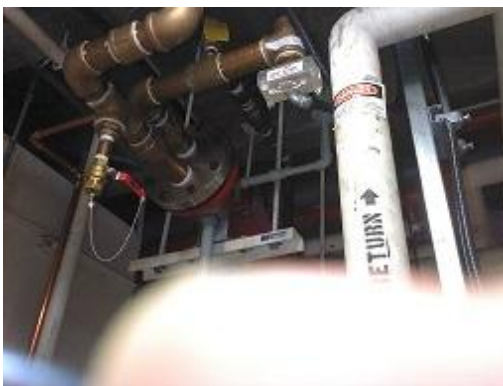
Figure 112 Conventional image of the same exchanger.

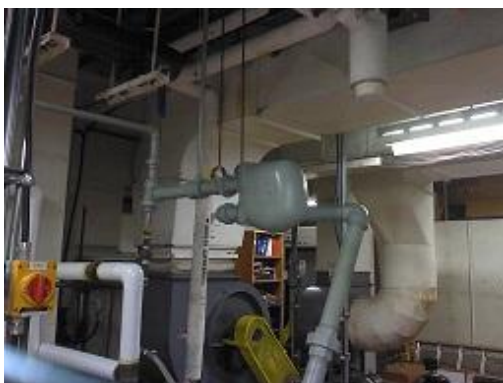
Figure 116 Conventional image of the same trap and piping.

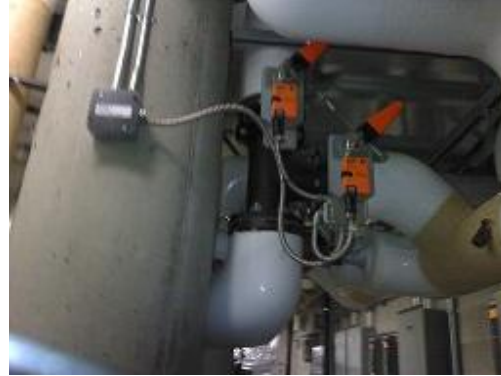
Figure 140 Conventional image of the same exposed pipe Tee.
