**SALAMANDER INSPECTIONS LTD**  
**Mechanical Insulation Energy Audits**

# Energy Audit

Victoria General Hospital  
1 Hospital Way,  
Victoria, B.C.  
V8Z - 6R5

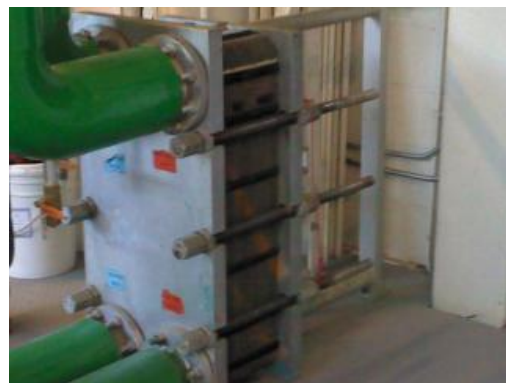
**Figure 2** This photo shows the same plate heat exchanger.

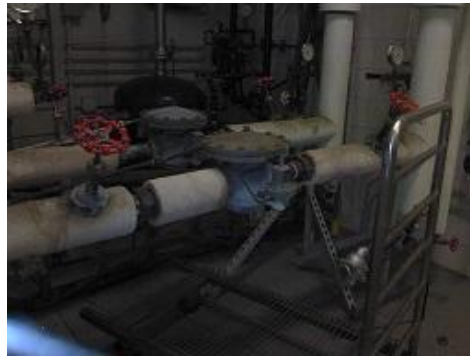
**Figure 4** This is a conventional photo of the same pump. There are also an exposed valve spindles and unions.

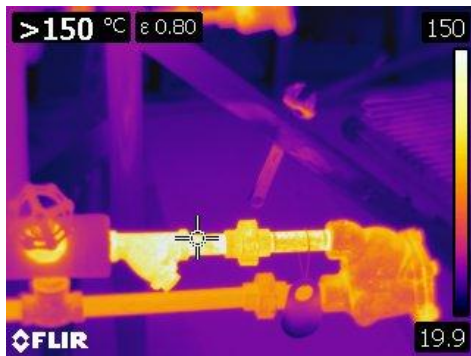
**Figure 5** This Thermographic image of a steam trap and piping below the previous valve assembly at 150° C or 302° F.
